Re: Limited Soil Sampling for the Essex Town Site Assessment
80 & 90 Upper Main Street, Essex VT 05452

Map 1: Site Location Map
Map 2: Site Vicinity Map
Figure 1 – Limited Soil Sampling Site Map

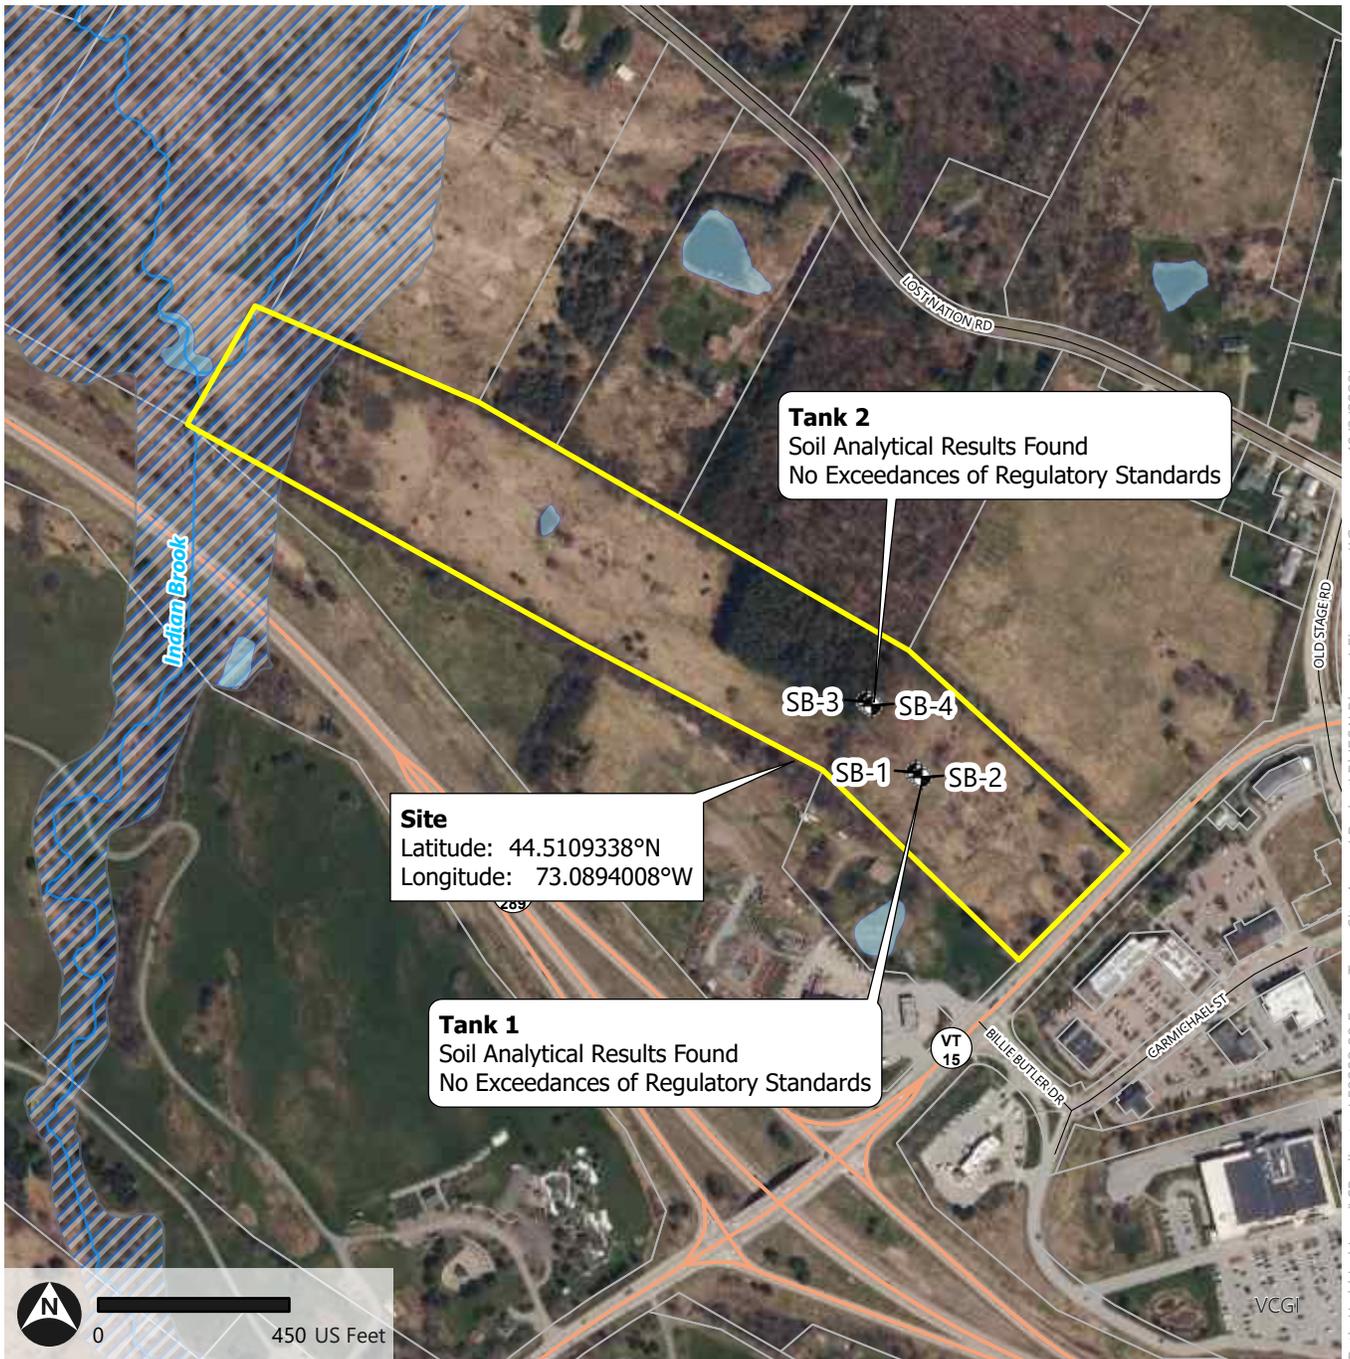
Figure 1 - Limited Soil Sampling Site Map

On September 12, 2023, VHB located the two aboveground storage tanks ("Tank 1" and "Tank 2") on the 80 Upper Main Street parcel (See Figure 1: Site Map). Tank 1 is in the open field portion of the parcel, approximately 465 northwest of the property boundary that borders Upper Main Street. Tank 2 is located at the edge of a more forested area and is approximately 700-feet northwest Upper Main Street. Significant vegetation was present around the tanks which was cleared by VHB, using hand tools, to allow access to the area surrounding the tanks. Both tanks appeared to be on their sides, and in generally poor condition. The tanks could not be moved as their structural integrity was significantly compromised and, if moved, any residual liquid that may exist in the tank would have likely been released.

Considering the tanks could not be safely moved, VHB advanced two shallow soil borings at an angle using a hand auger at each of the two ASTs present on-Site (totaling four borings) to evaluate soil beneath the former tanks. Soil borings 1 and 2 (SB-1 and SB-2) were advanced at Tank 1 and borings 3 and 4 (SB-3 and SB-4) were advanced at Tank 2. When necessary, the angle utilized allowed field staff to access soil just under the base of the tanks at the soil interface. Borings were extended past the two-foot mark where possible to minimize the depth lost through angulation of the boring and capture the representative soil profile. Borings were advanced to a depth of approximately 24-28 inches depending on refusal. Soil was screened using a photoionization detector (PID) at 8-to-12-inch intervals to field screen the headspace above the soil for the presence of volatile organic compounds (VOCs). General soil characteristics were noted (color, grain size, presence of anthropogenic materials, odors, etc.).

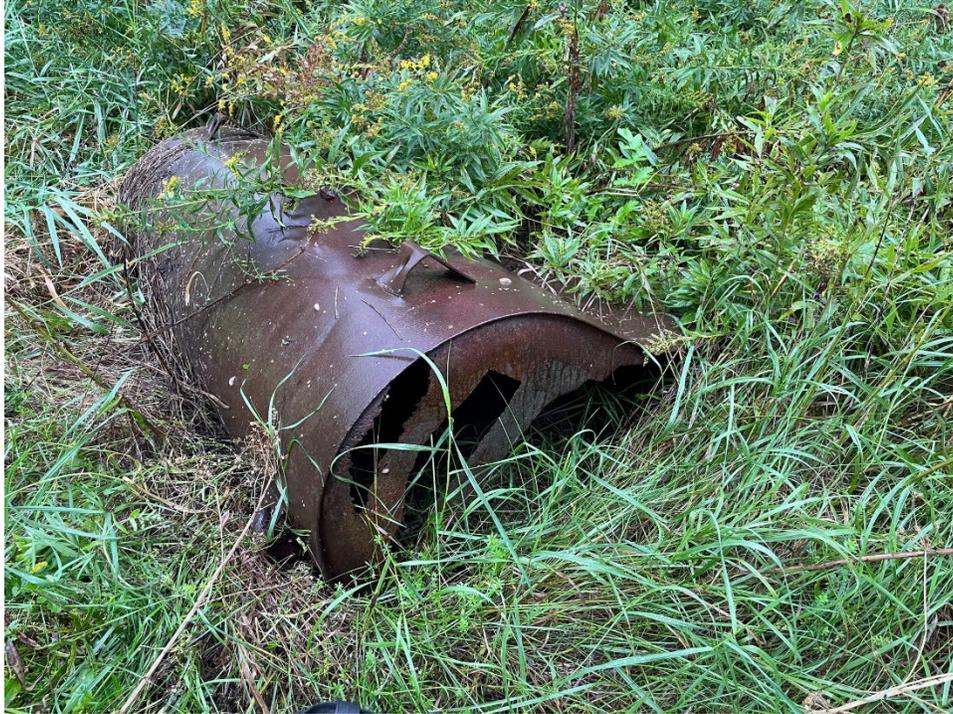
The PID readings from the soil screening on September 12, 2023, ranged from 0.0 to 0.5 parts per million by volume (ppmv). The highest reading occurred from 0-8 inches in SB-2 beneath the southern end of Tank 1; however, the values recorded do not indicate that a release occurred or there is contamination present. These readings instead were likely due to precipitation and high moisture content in the upper soil profiles during the day of sampling, which can influence the PID readings. No staining or petroleum odors were noted at any time during this limited assessment. Soils beneath Tank 1 generally consisted of sand with varying amounts of gravel, with a darker coloration towards the surface, and a more yellow brown to reddish coloration from 16-28 inches depths. Soils beneath Tank 2 generally consisted of fine sands with little to no gravel. In summary, the field screening readings and recorded observations suggested no indications that a petroleum release occurred at either tank location that was evaluated.

Photo 1: View of Tank 1 (southeast facing)

Based on field observations, screening results, and analytical laboratory results described above, it is VHB's opinion that a significant release of petroleum did not occur at either of the current tank locations on the

80 Upper Main Street parcel. At this time, VHB does not recommend further investigation be performed related to these tanks.

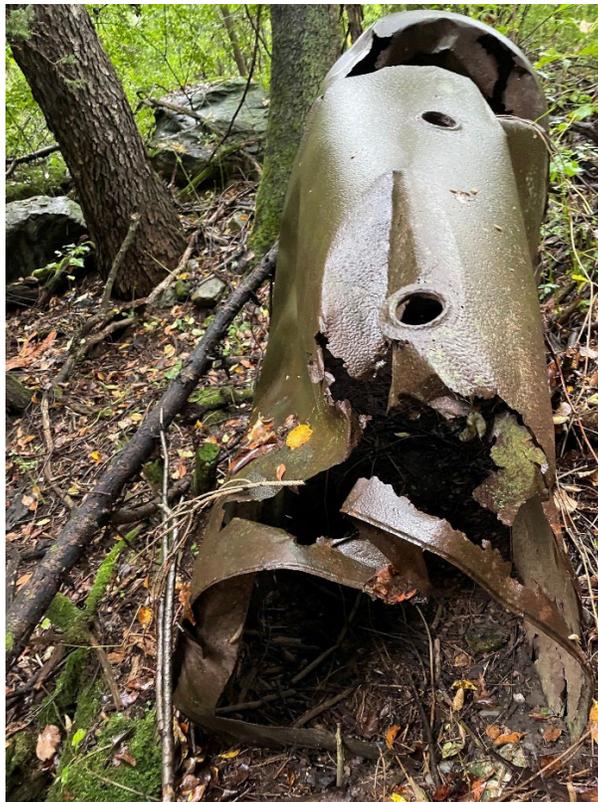
Photo 2: View of Tank 2 (east facing)
