HISTORIC SITES & STRUCTURES SURVEY
District Complex Survey Form

SURVEY NUMBER: 0405-23

Essex Center Historic District

HISTORIC SITES & STRUCTURES SURVEY
Individual Structure Survey Form

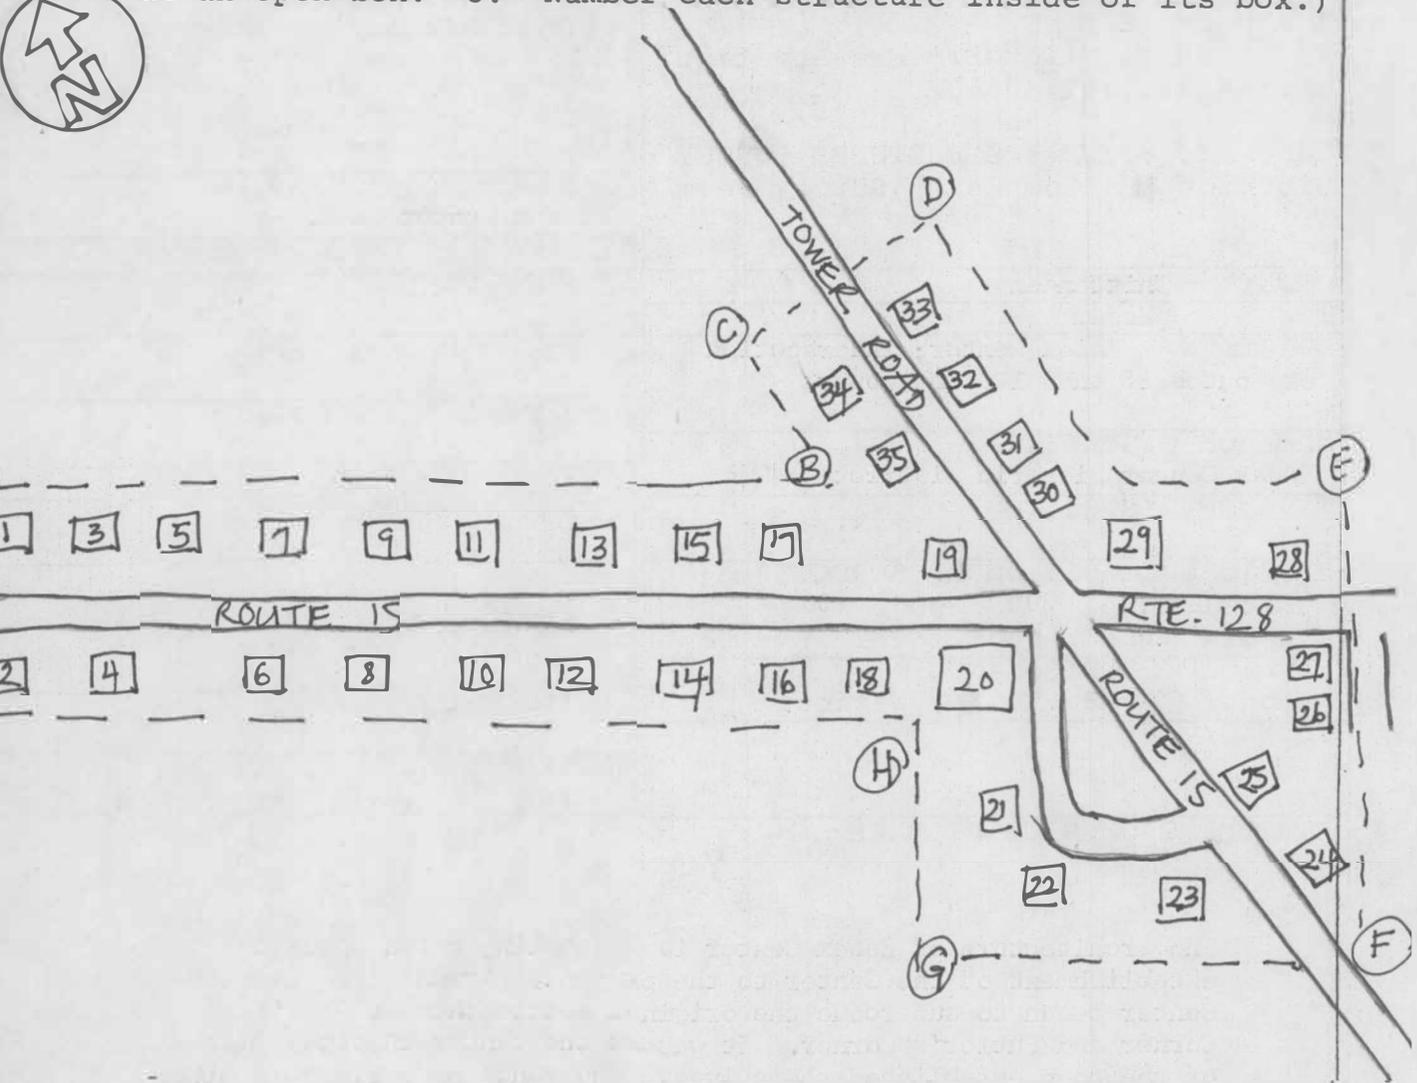
MAP: (1. Indicate NORTH in circle. 2. Represent each structure as an open box. 3. Number each structure inside of its box.)

the district boundary proceeds north to point H, southwest corner of the Reynolds property, including the rear line of the Potvin lot. It continues west northwest along the rear property lines of the buildings along the south side of Route 15 to point I, southwest corner of the Shortsleeve property. The line proceeds north to point A where the boundary began. The boundary thus described includes all structures within its borders designated by numbers 1 through 35 and represented in the above map.

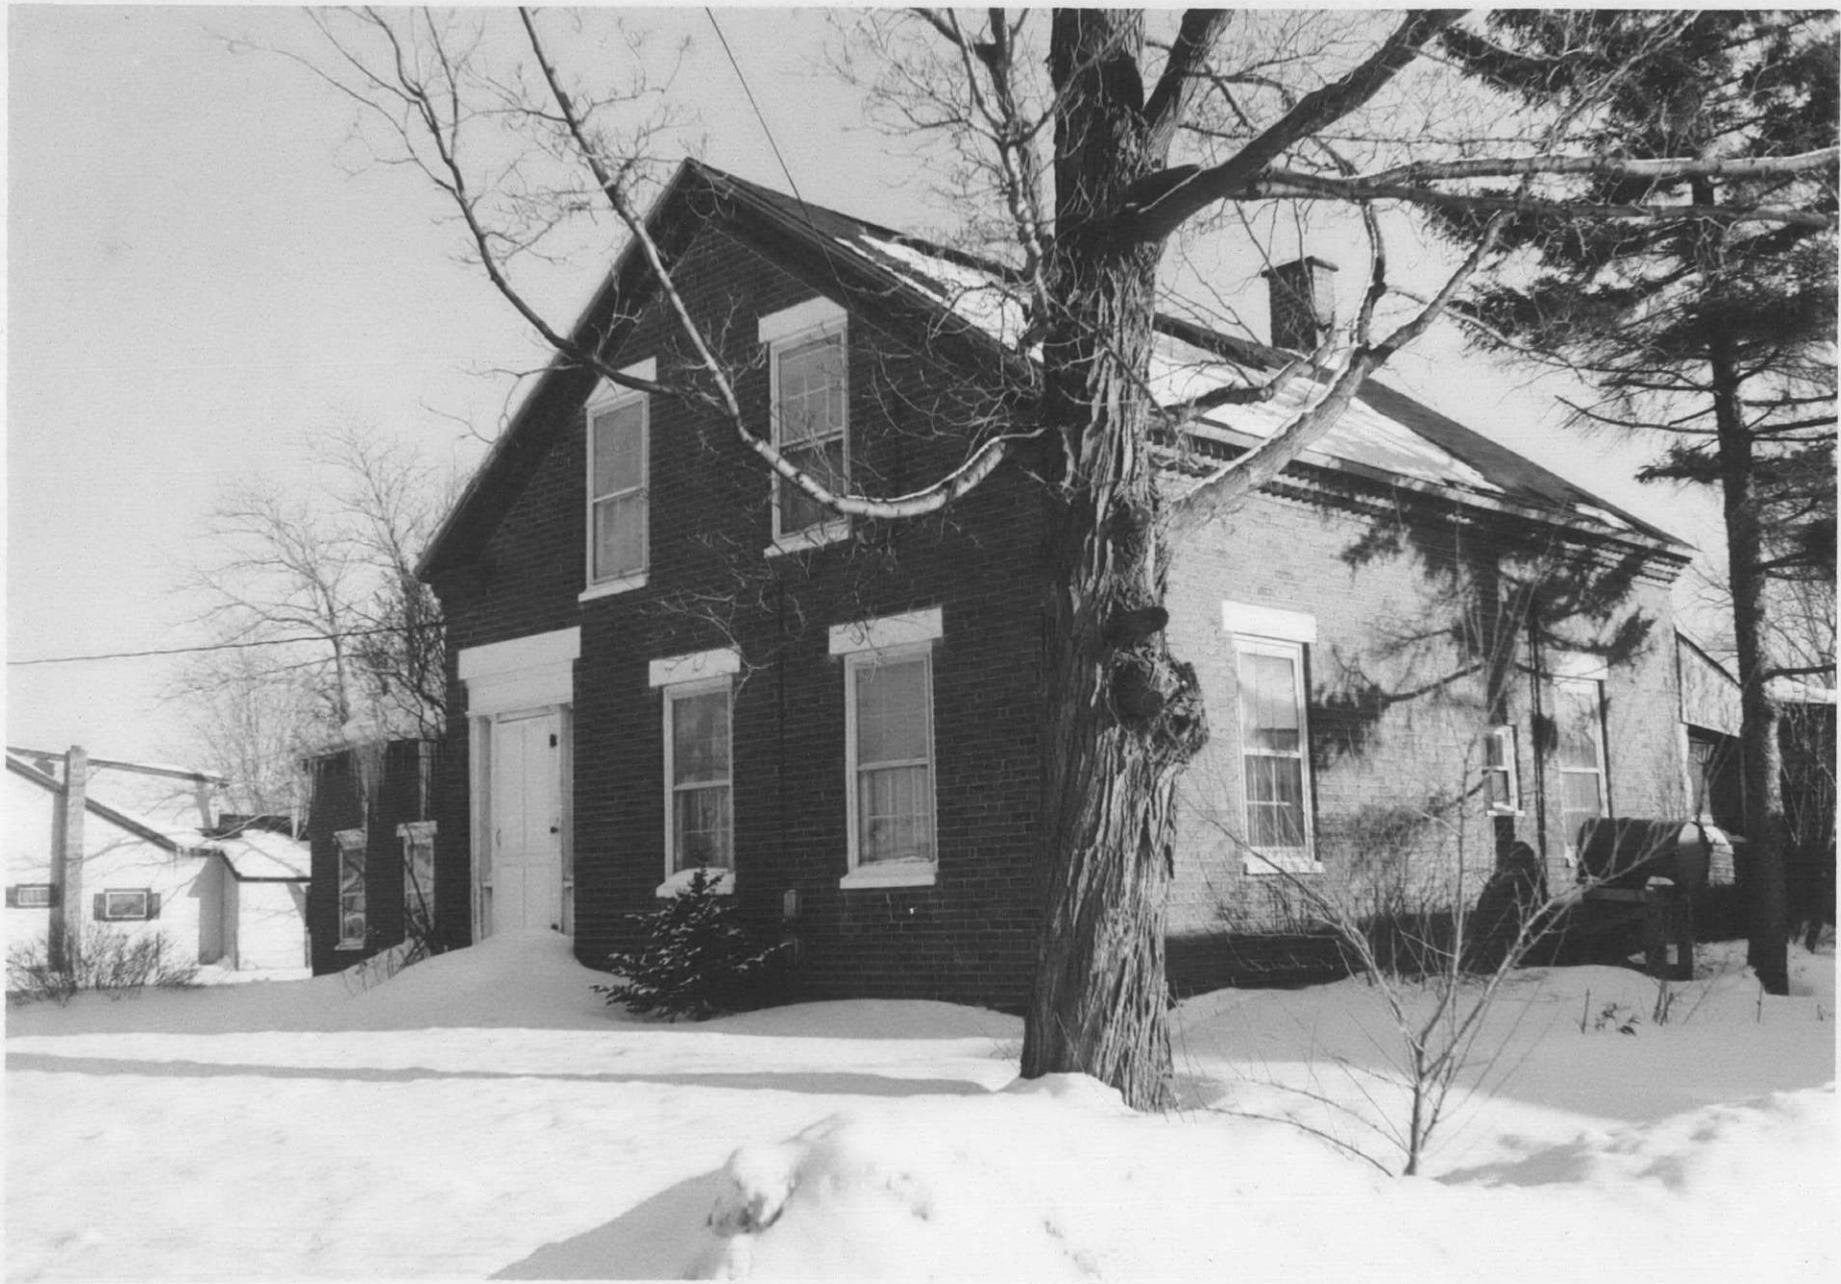
#2

The main block is gable-front, 3 x 2 bays, sidehall plan. An ell extends to the south. The molded window heads are also peaked.

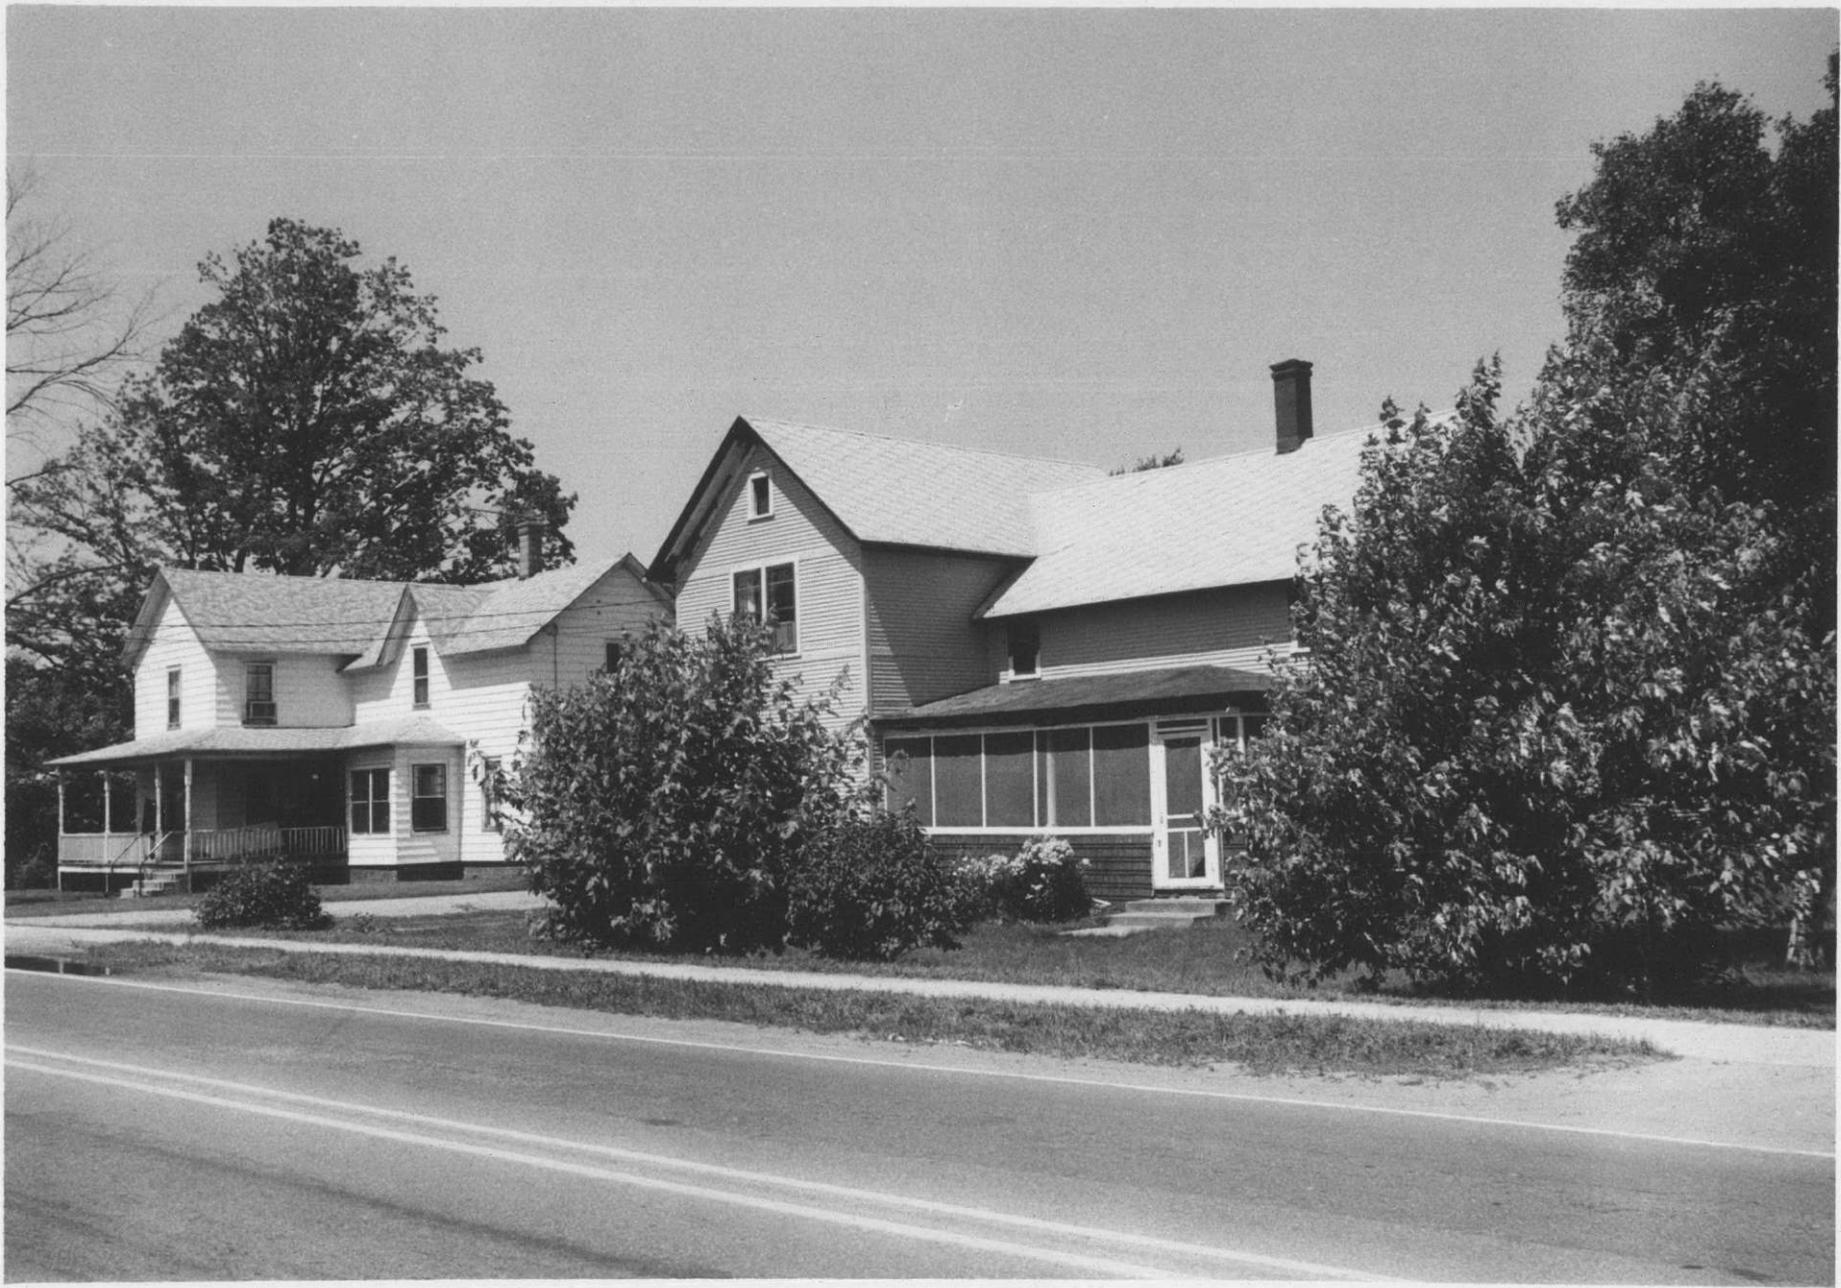
#5 & 7

MAP NUMBER: 5	DATE BUILT: 1870-1900	SURVEY NUMBER: 0405-23
FUNCTIONAL TYPE: Dwelling	NEGATIVE FILE NUMBER:	
COMMON NAME:	OWNER: Reginald Esmond	
DESCRIPTION:		
<p>This structure, sided in vinyl, consists of a 1 x 2 bay gable front block and side (east) ell. The ell has a central gable wall dormer and on the first floor is a central bay window. Turned posts support the veranda.</p>		
MAP NUMBER: 7	DATE BUILT: 1870-1900	SURVEY NUMBER: 0405-23
FUNCTIONAL TYPE: Dwelling	NEGATIVE FILE NUMBER:	
COMMON NAME:	OWNER: Rene Desany	
DESCRIPTION:		
<p>This clapboard-sided structure has a 1 x 2 bay gable-front block and side (east) ell with enclosed shingle porch.</p>

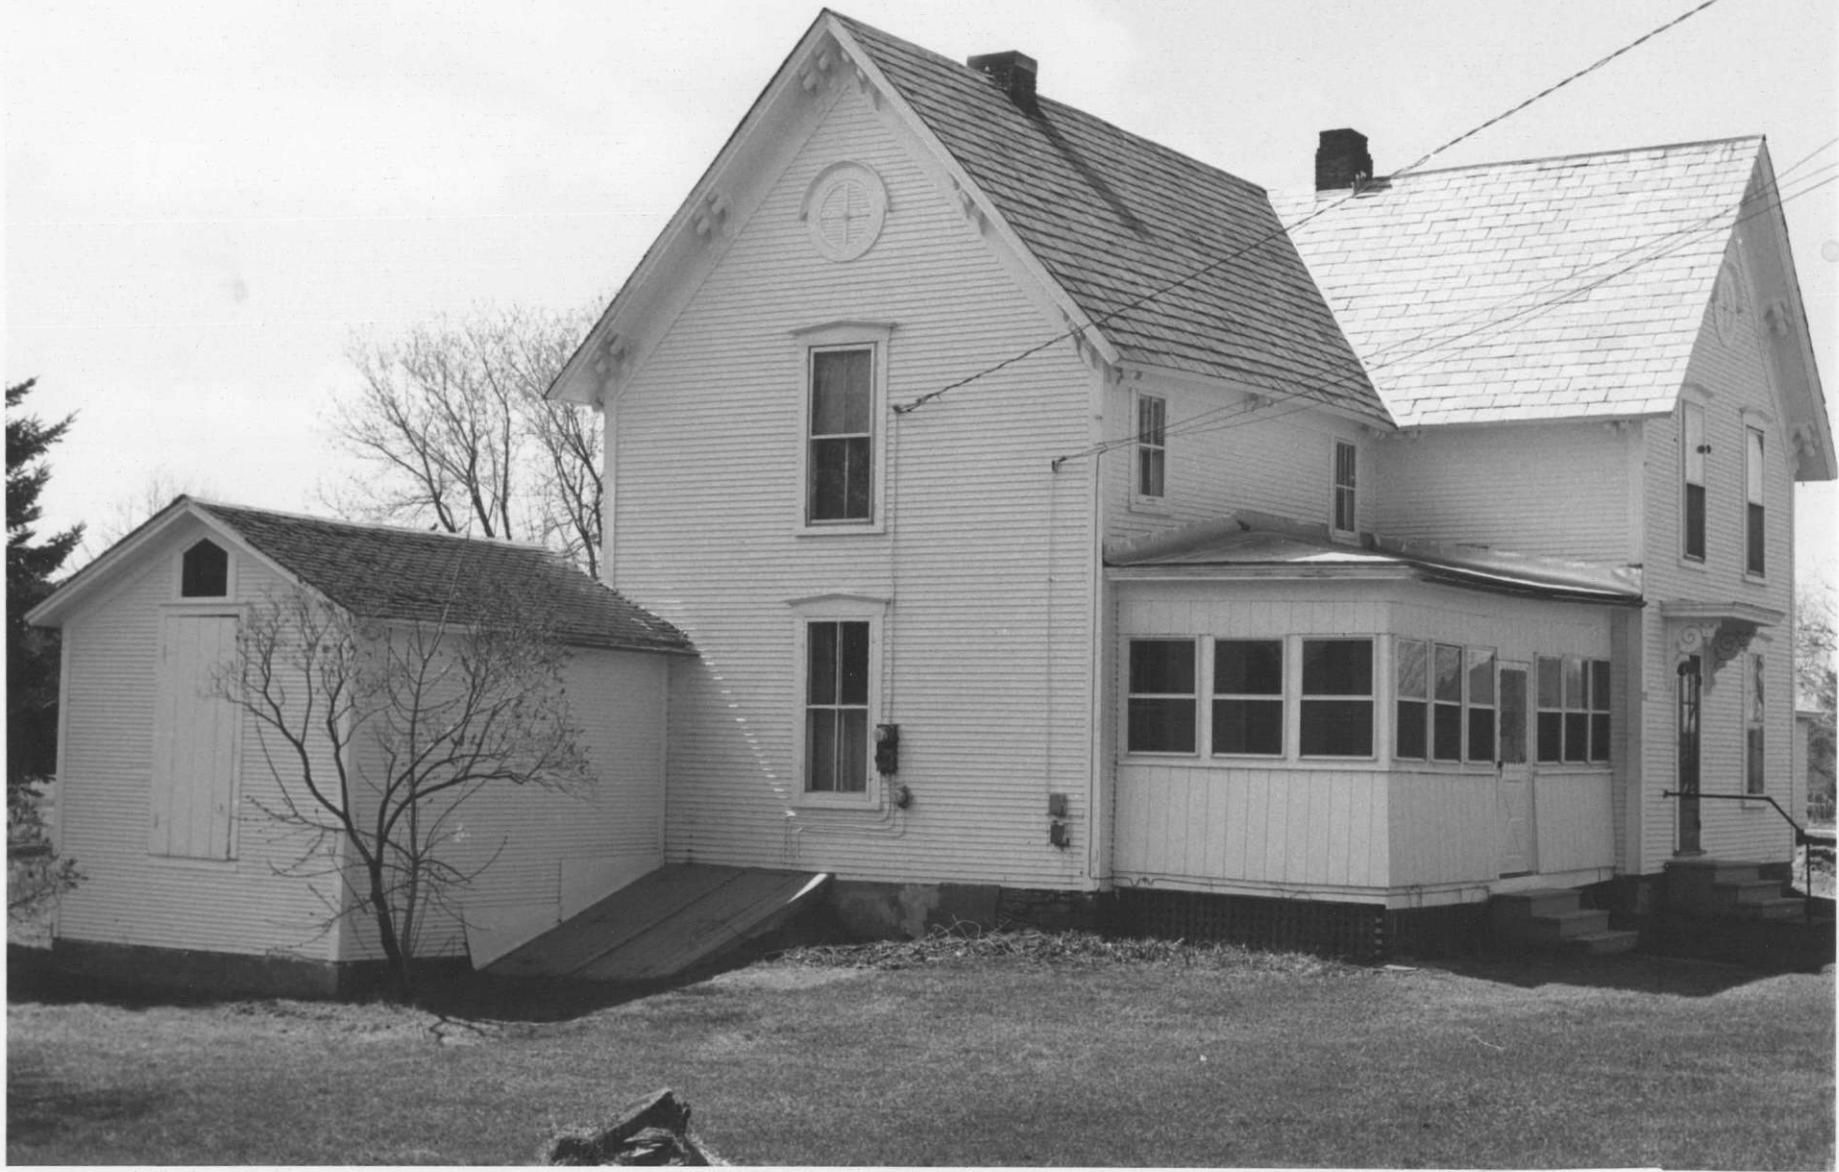
#8

This clapboard-sided structure is in the Italianate style. The gable-front main block has a round louvered attic vent. Both the side (east) ell and block have paired brackets supporting the cornice and peaked door and window heads. The entry door is sheltered by a flat hood supported by curved sawn brackets.

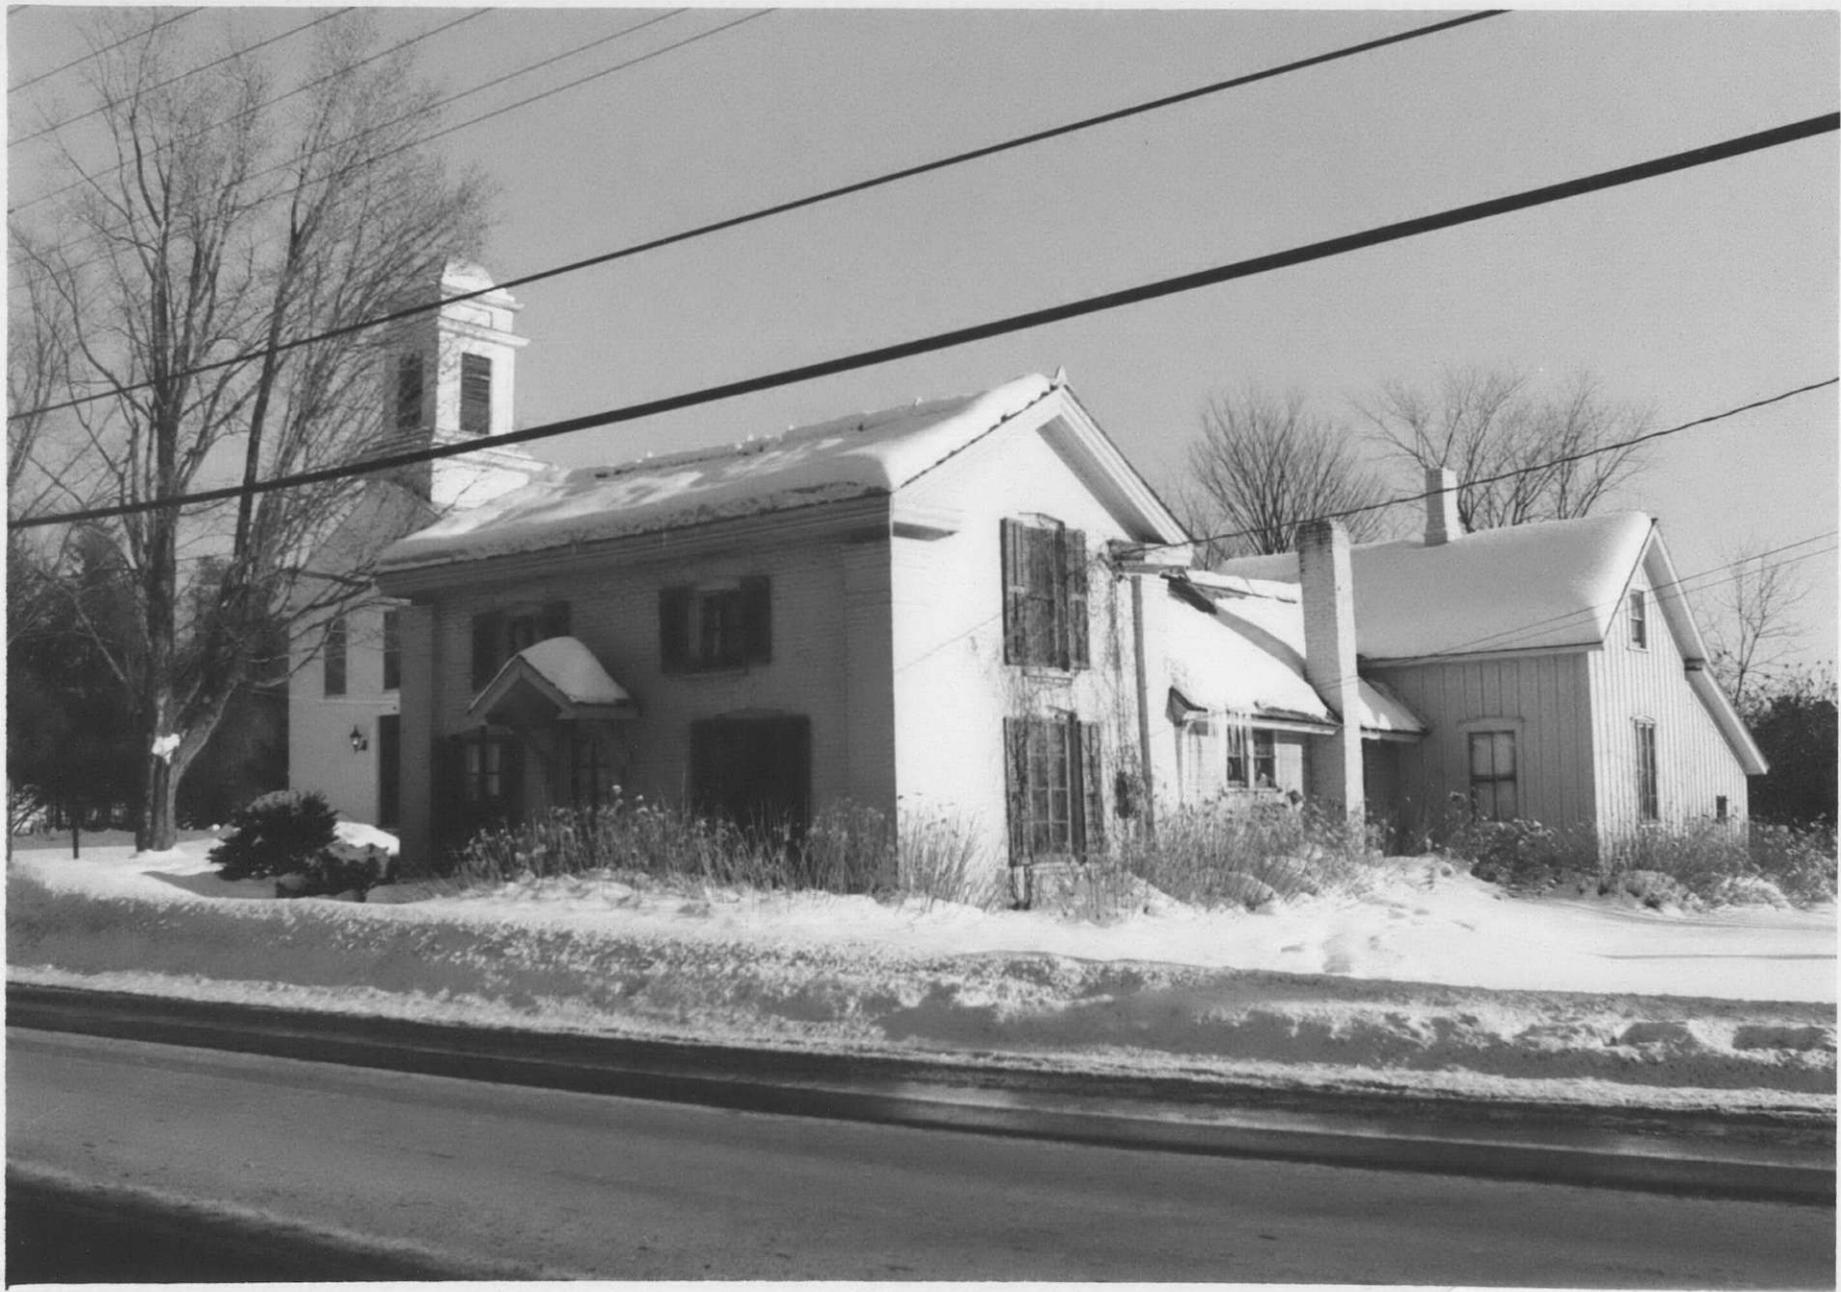
#10 & 12

The painted brick main block is 3 x 1 bays and includes corner pilasters, segmentally-arched window lintels above pointed arched wooden heads, and an east bay window. A clapboard ell extends to the rear which has an attached board and batten addition. The detailing of the structure is largely Gothic, probably added after construction. The pilasters may have been a subsequent addition, probably preceding the "gothicization" of the house.

The church is clapboard-sided and has a gable-front orientation. The six-panel door has a peaked head. All three levels of the belfry terminate in a cornice.

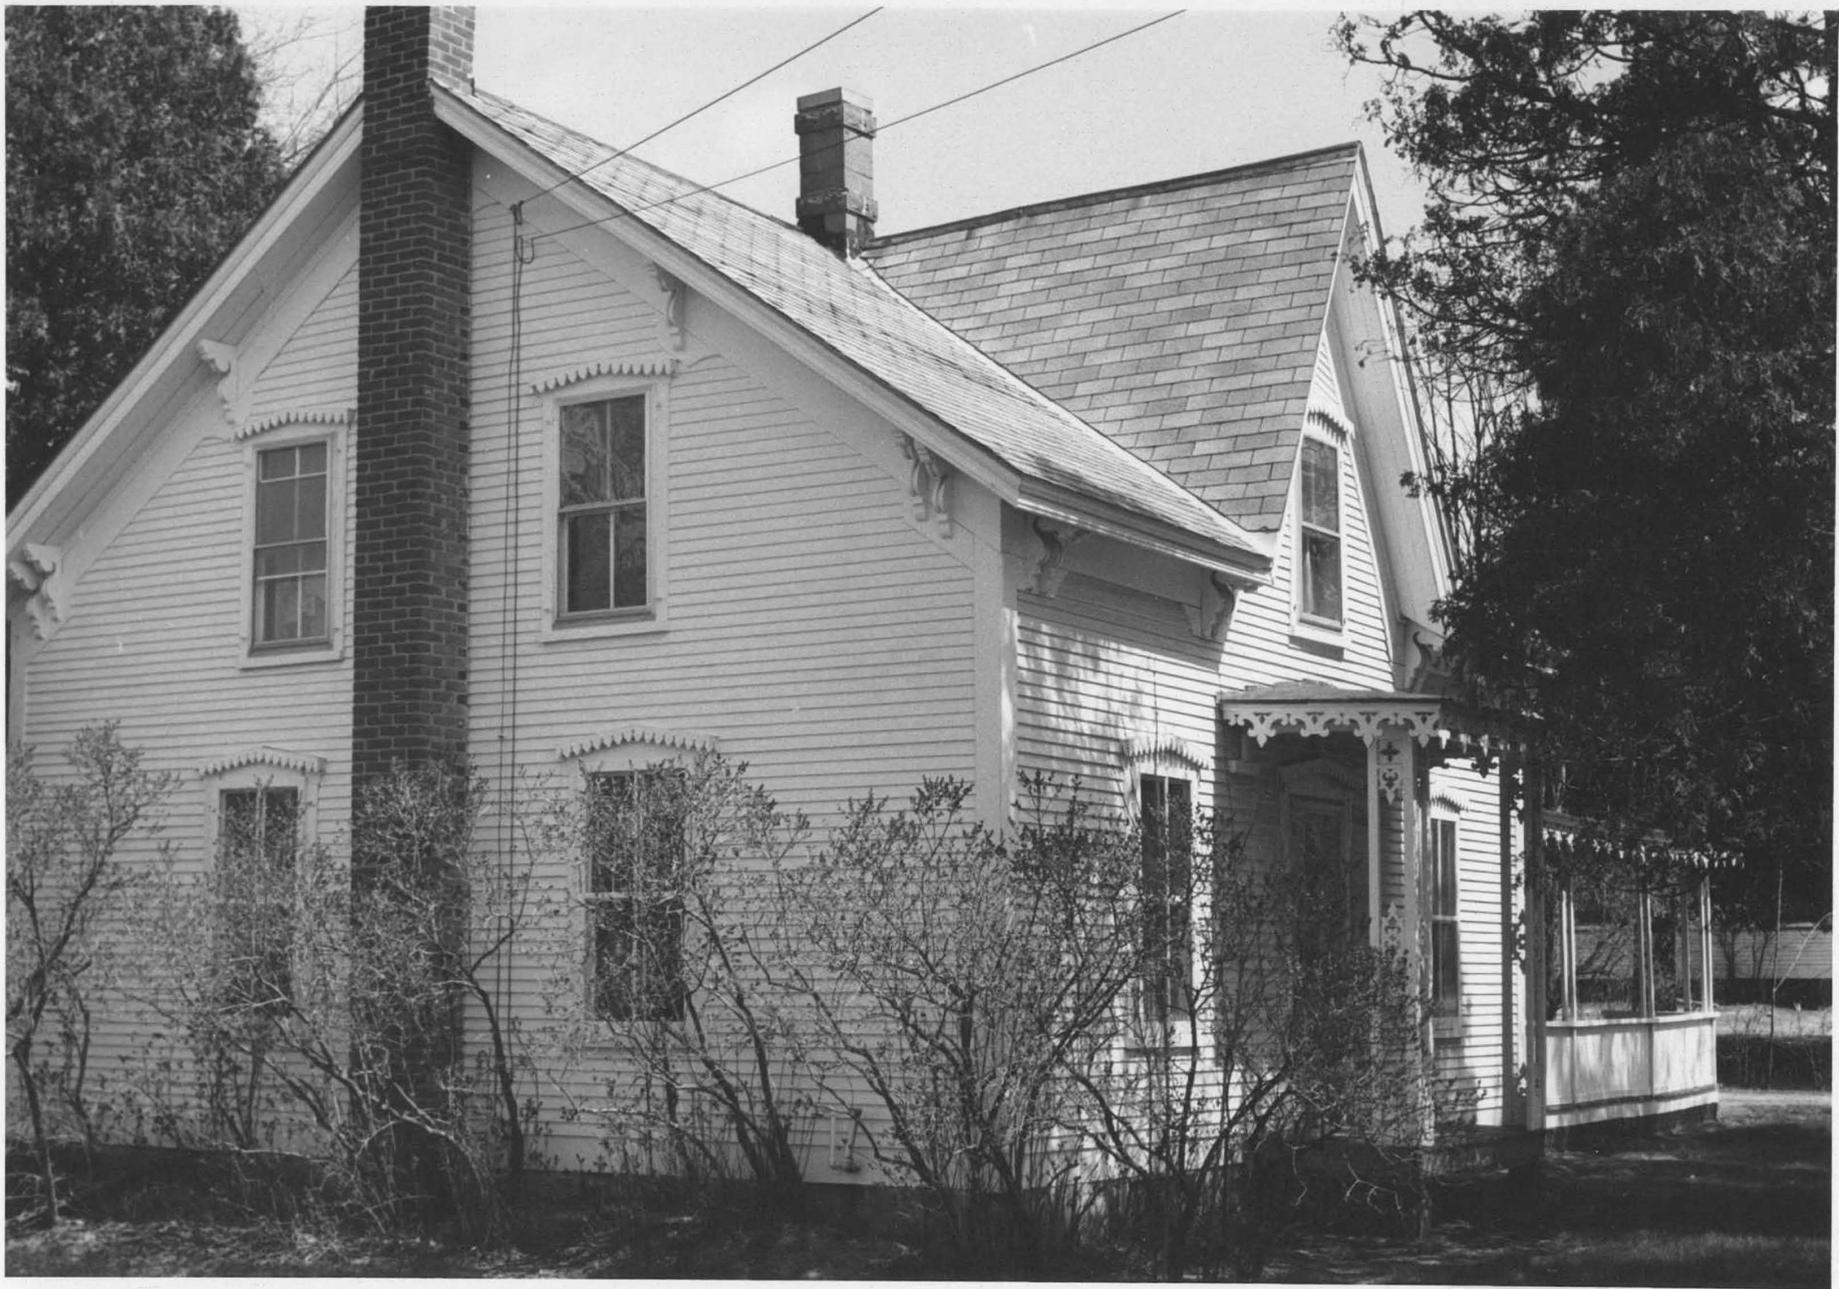
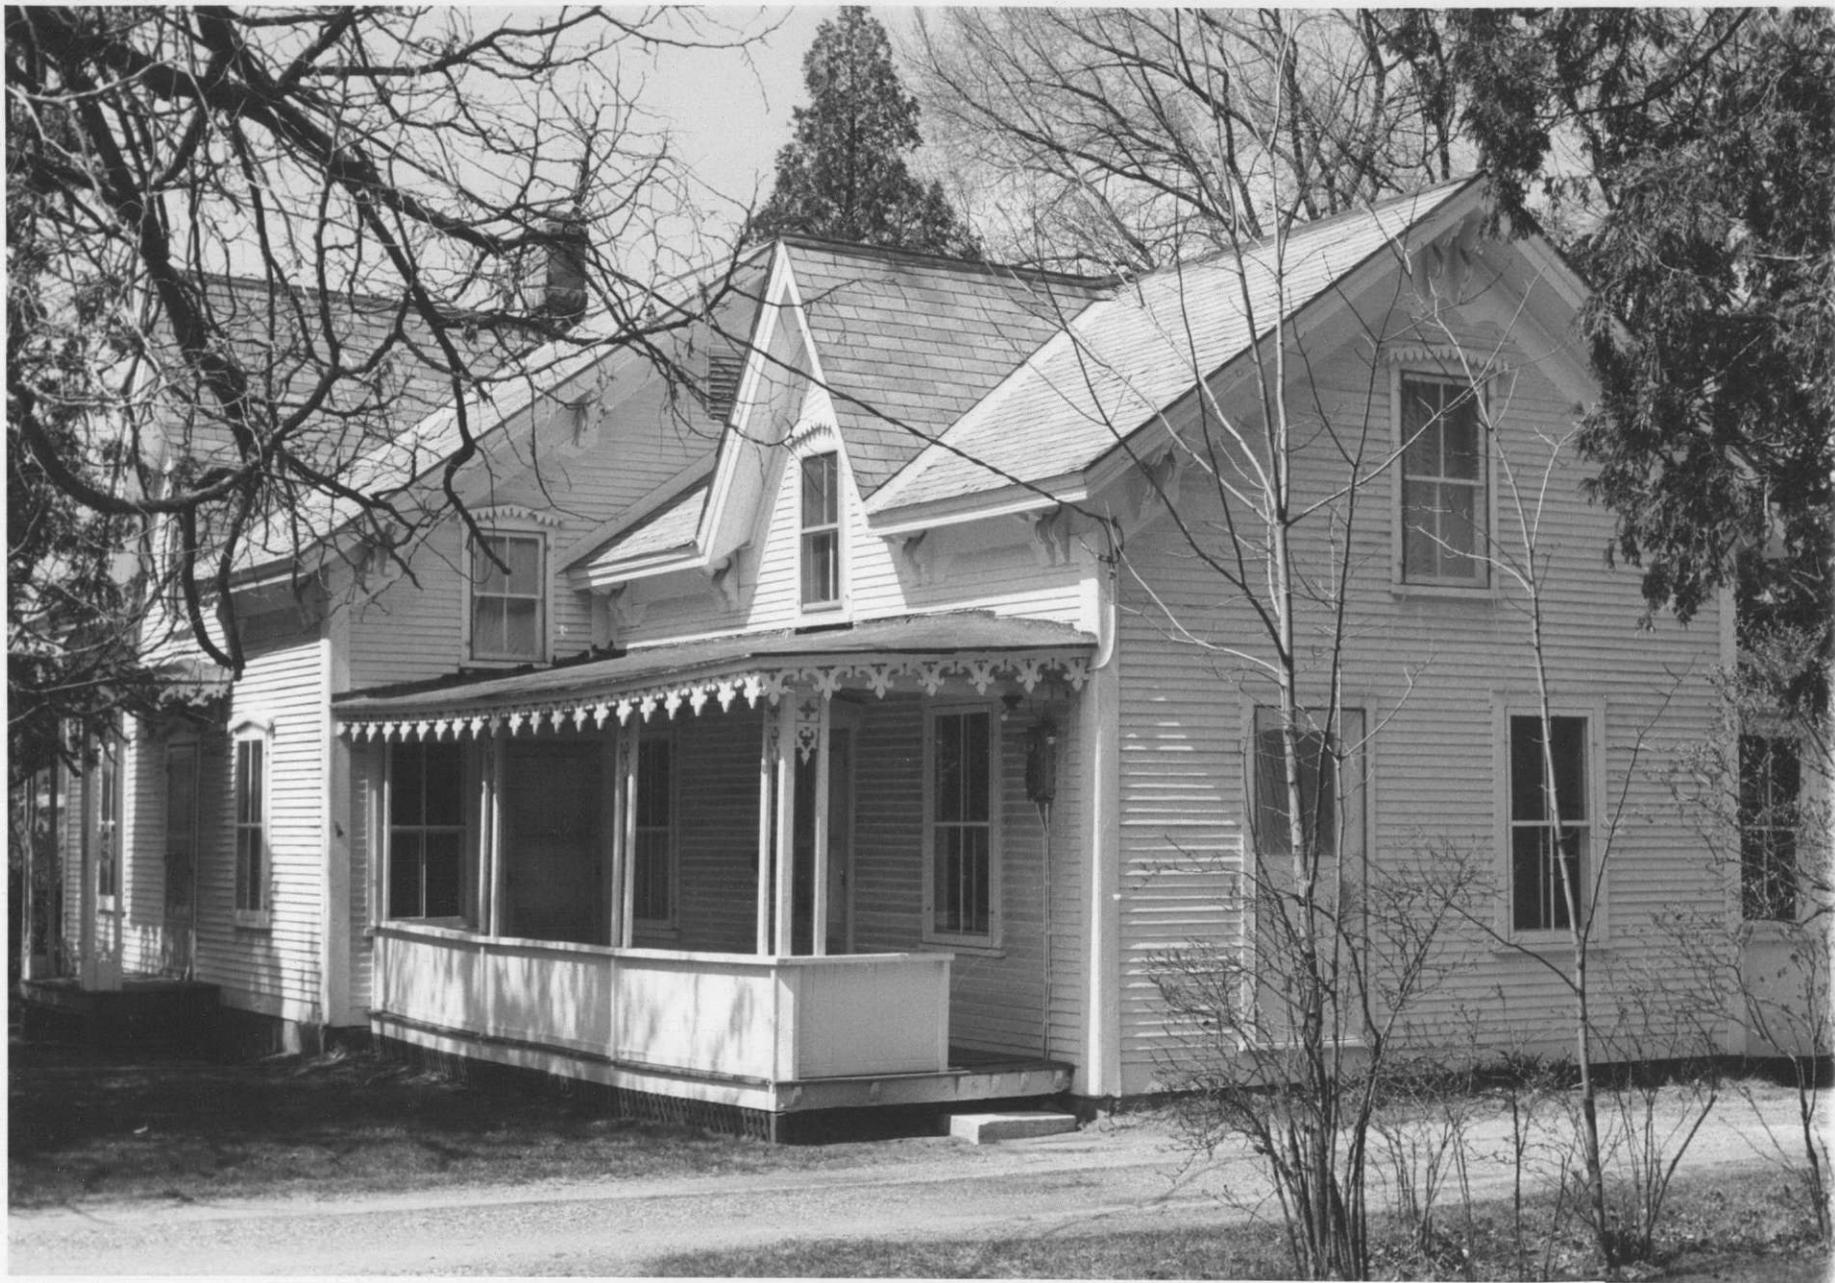
#11

This Gothic Cottage is sheathed in clapboards. The main block is three bays across with a central gable wall dormer. The single bay entry porch is decorated with vergeboards of a fleur-de-lis motif. The side ell also includes a central wall dormer. Its porch is supported by incised piers. Both sections of the structure have paired brackets supporting the cornice and vergeboards decorating peaked window heads.

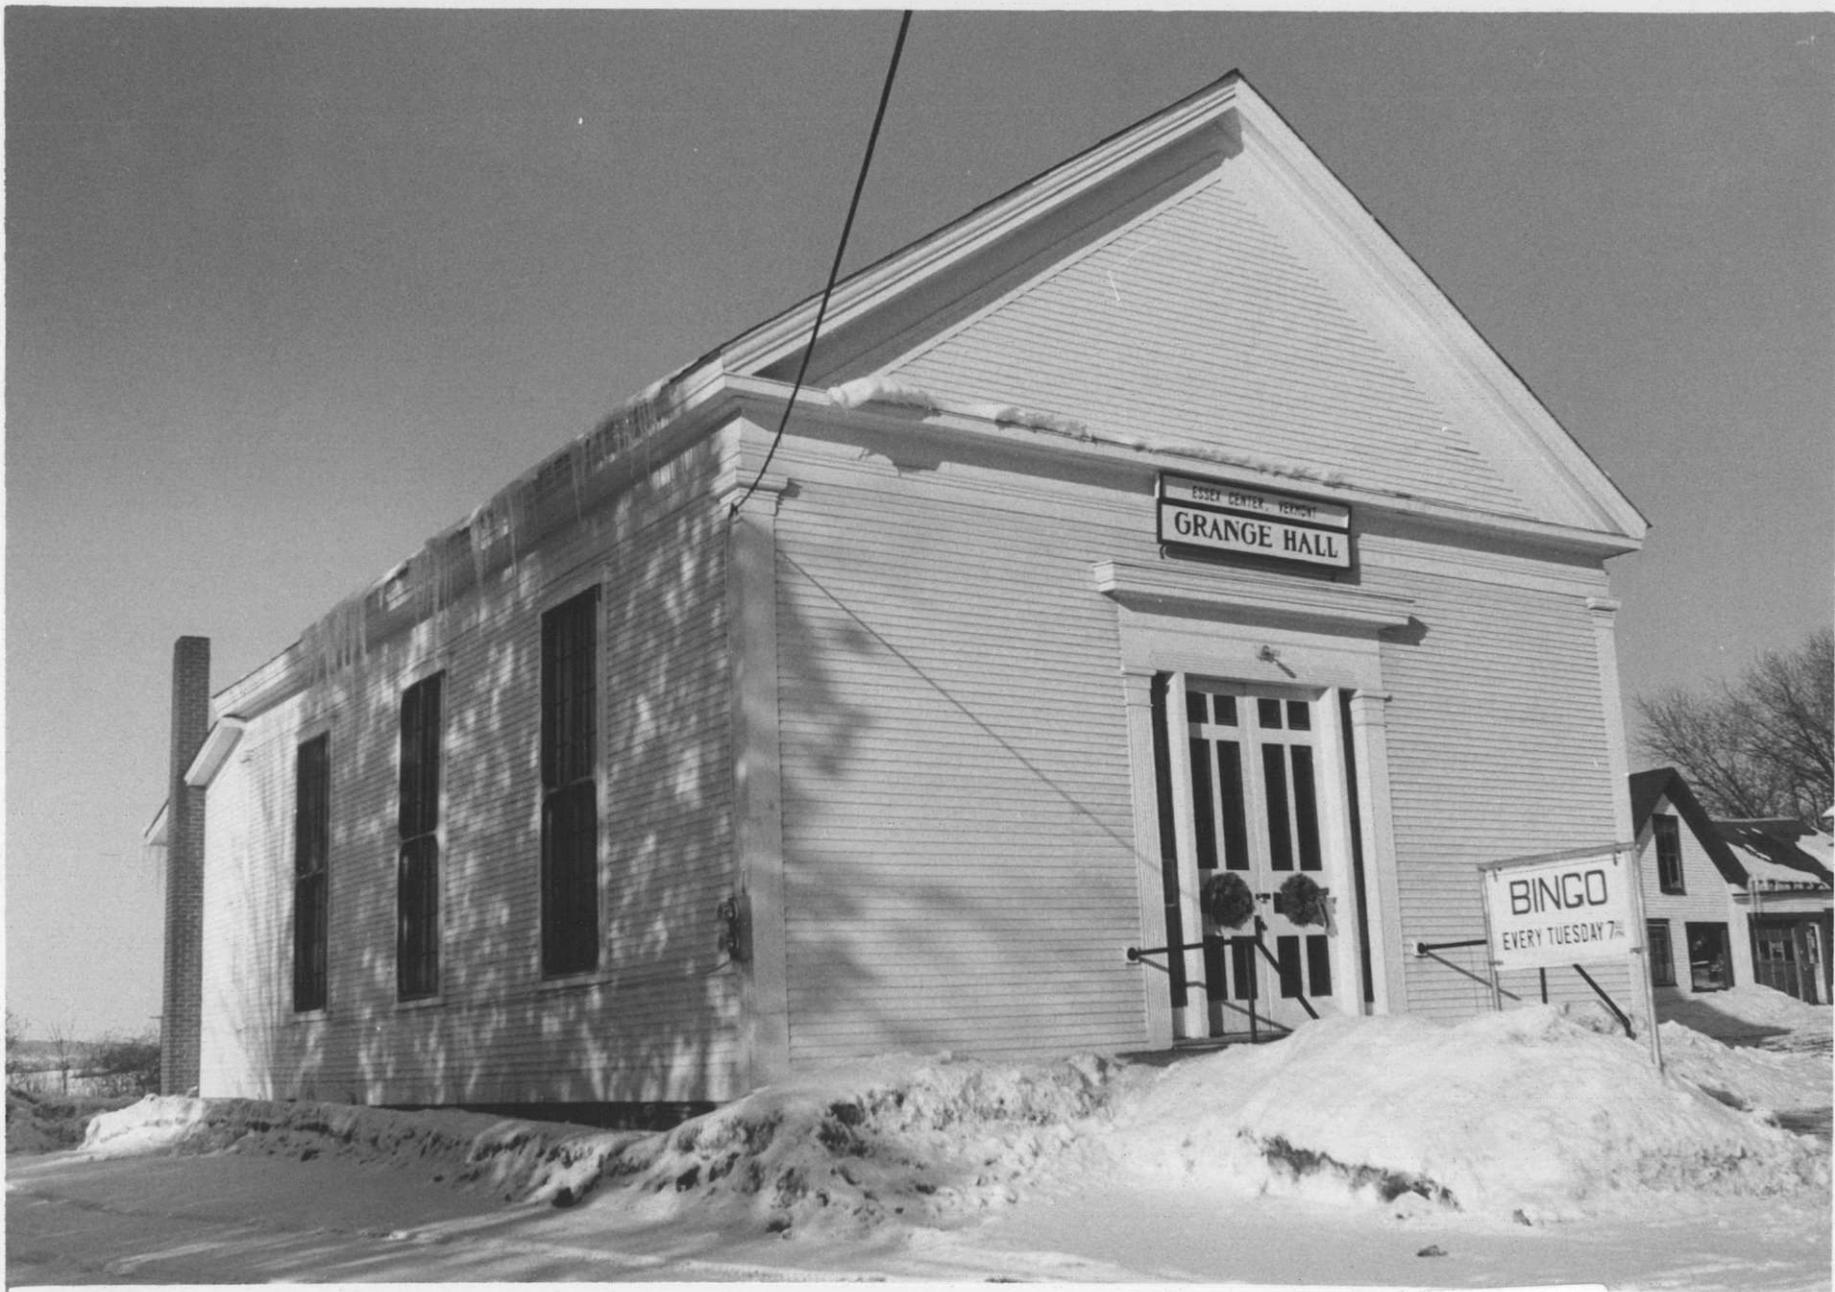
#13

This clapboard-sided structure is gable front with pediment and includes corner pilasters. The double leaf panel doors flanked by rectangular side lights and pilasters supporting a partial entablature is the only opening on the front face. The structure is three bays deep. It served as the Universalist Church until 1893.

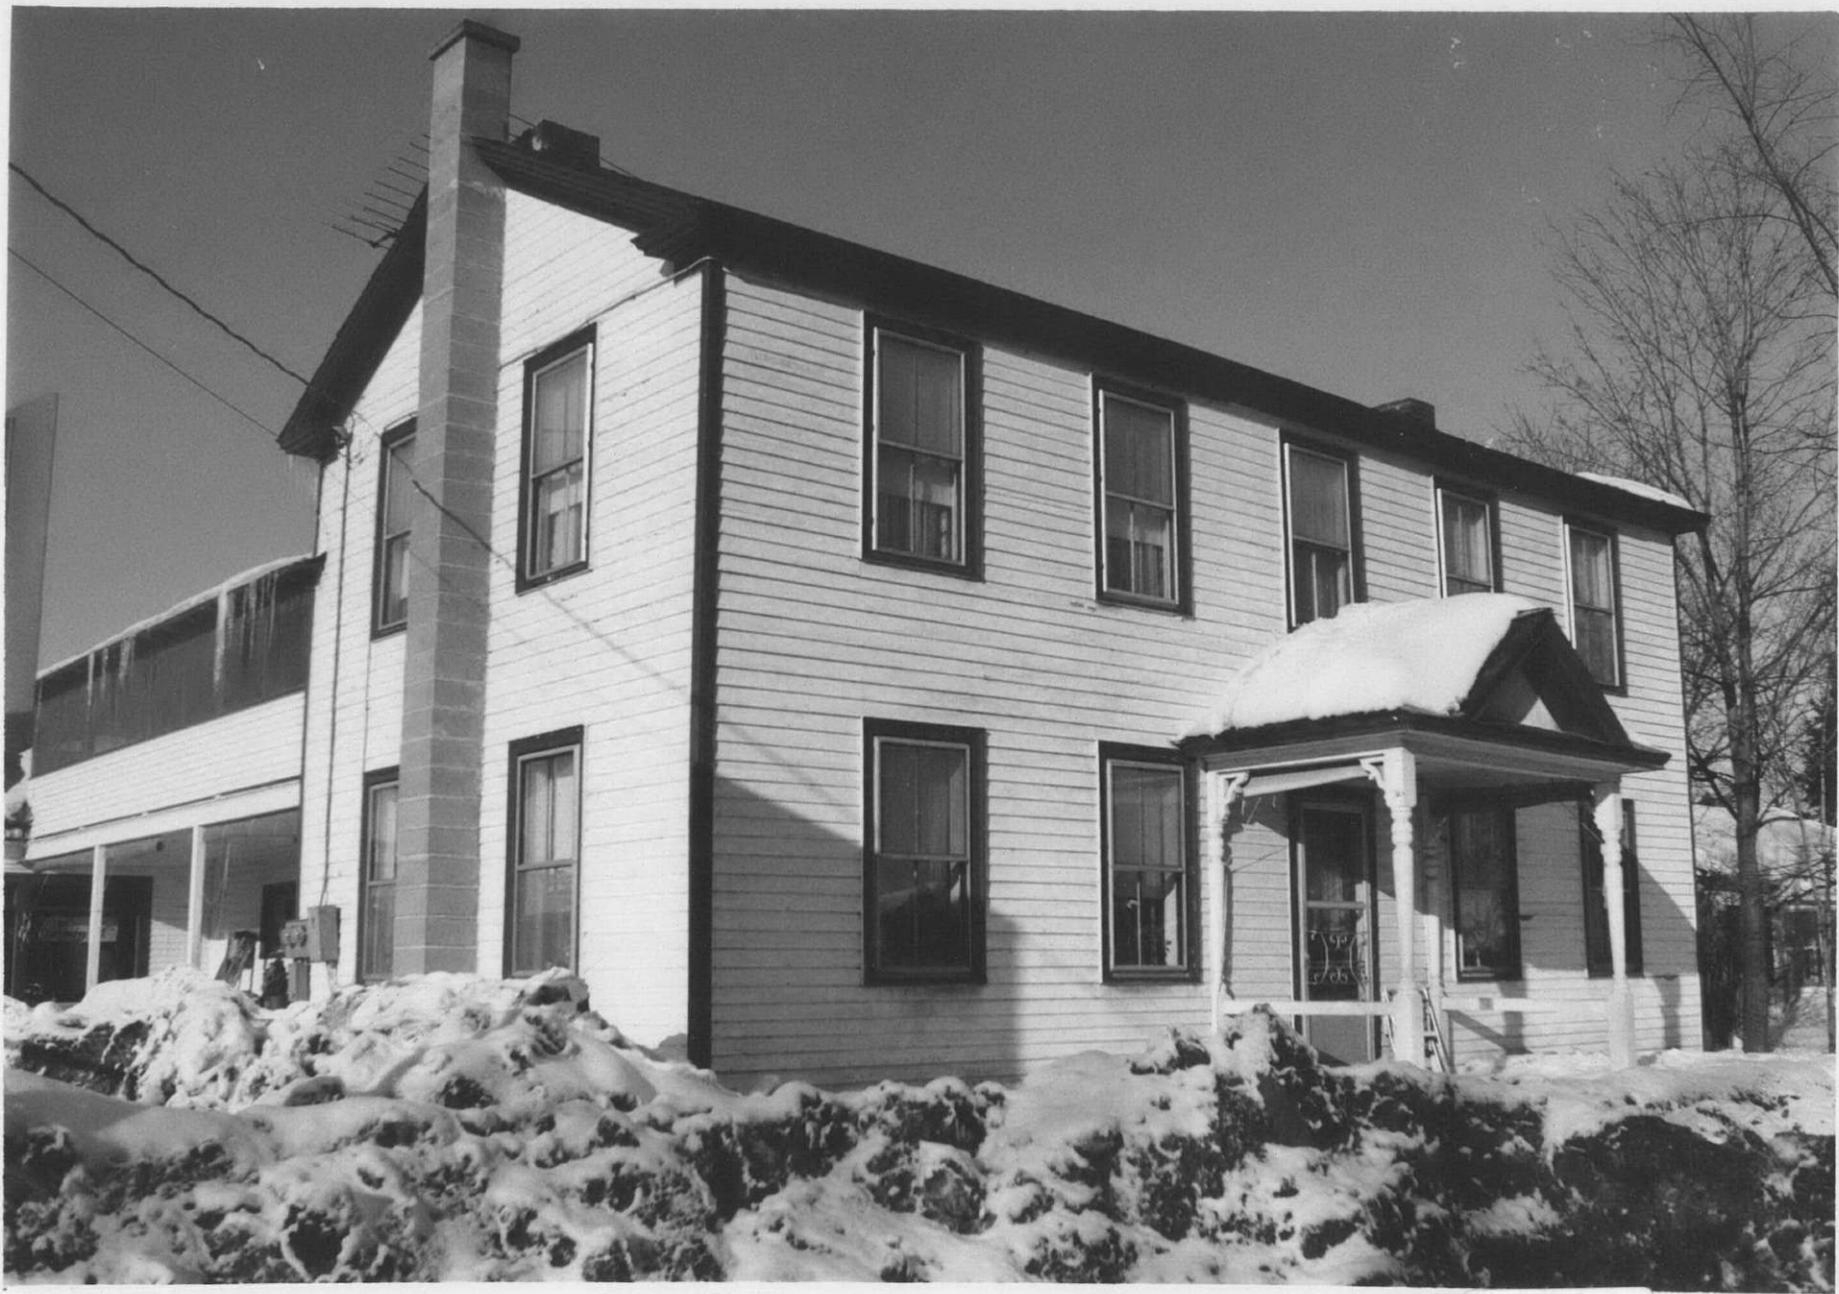
#15

The main block of this clapboard structure is 5 x 2 bays with center hall and is two-stories in height. Window surrounds are molded. Turned posts and incised brackets support the entry porch with its hip roof and central peak. An ell extends to the rear and is attached to the store to the west. The structure was built by Thaddeus Fletcher to serve as his residence and store after he outgrew his original store in building # 20.
