HISTORIC SITES & STRUCTURES SURVEY
District Complex Survey Form

SURVEY NUMBER: 0405-23

Essex Center Historic District

HISTORIC SITES & STRUCTURES SURVEY
Individual Structure Survey Form

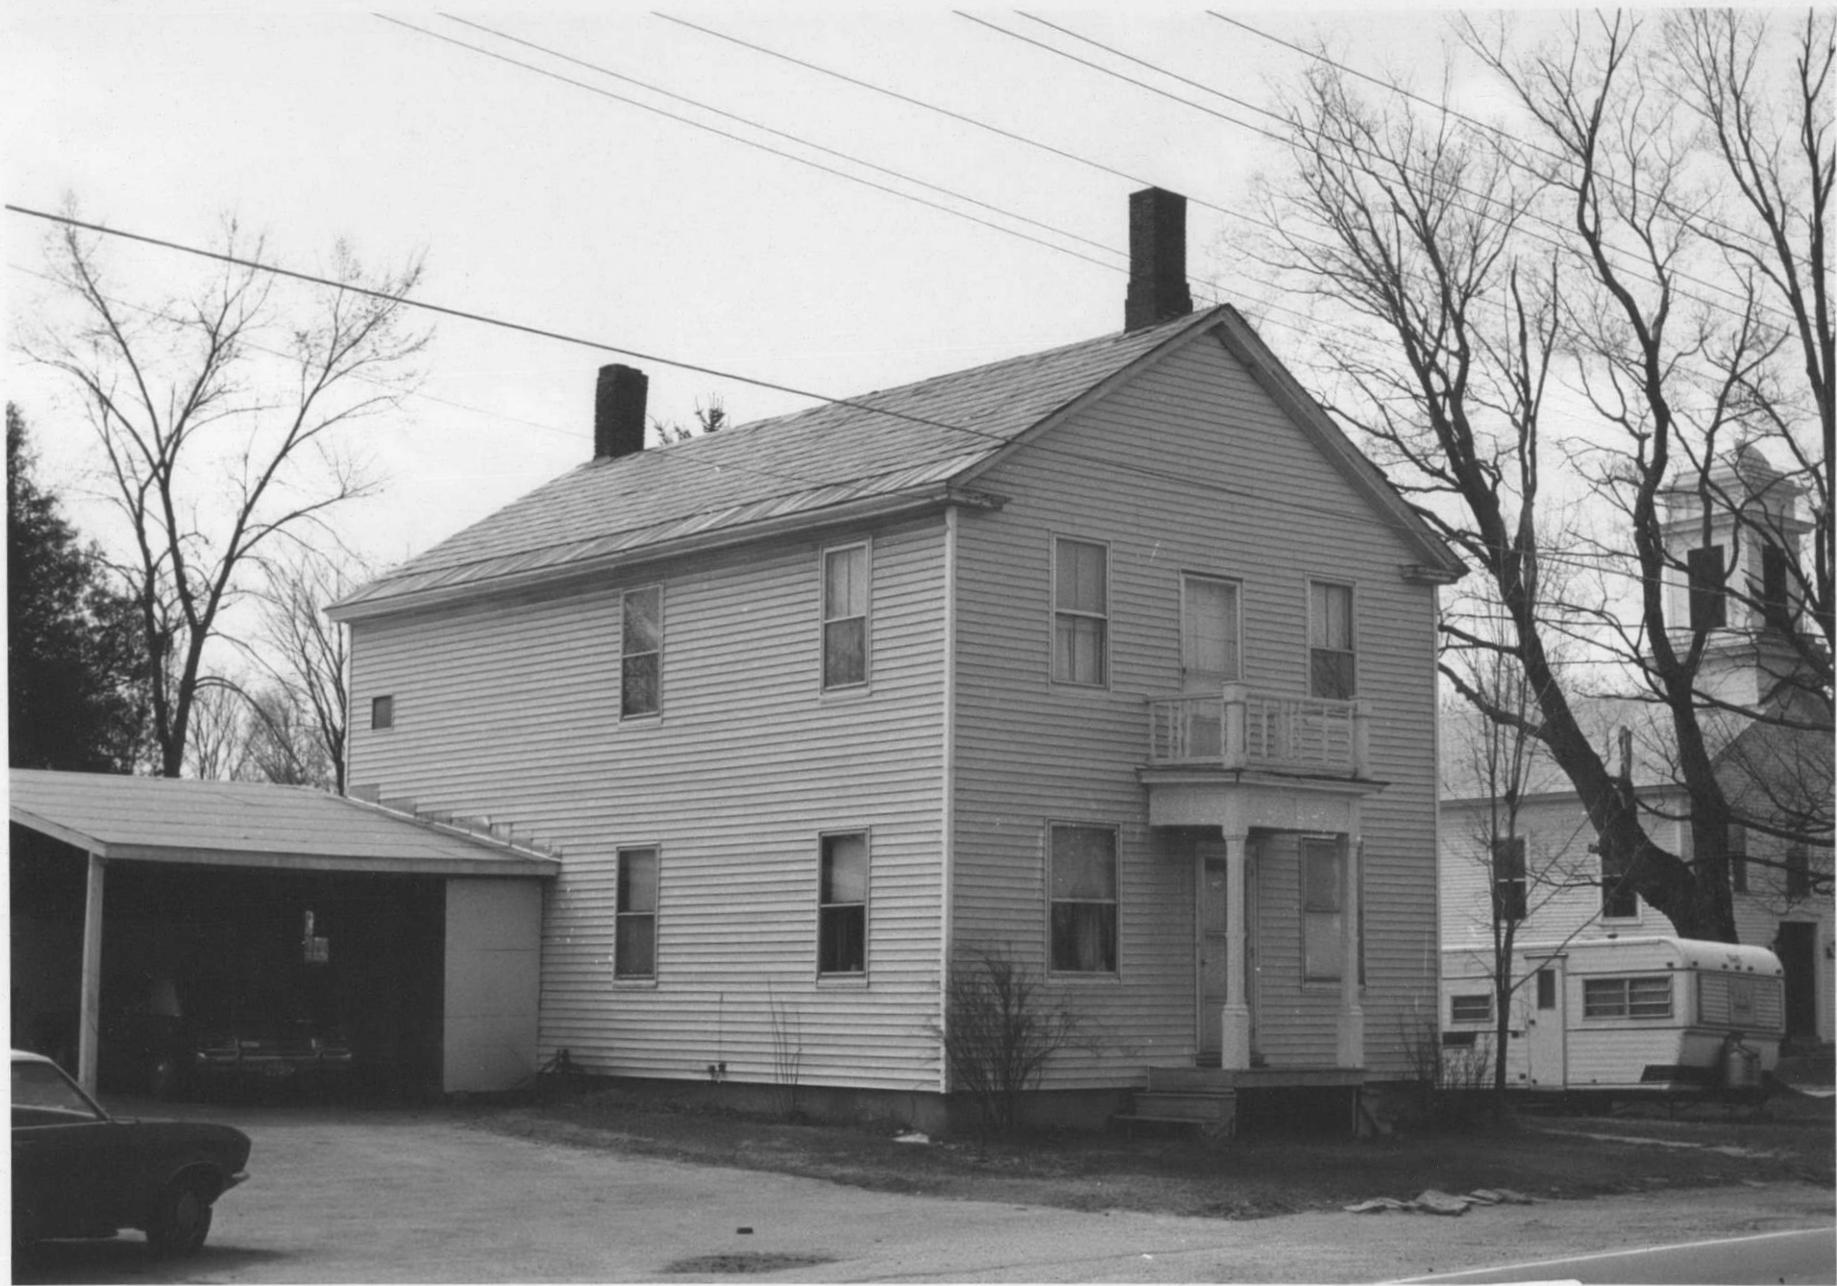
#14

This aluminum-sided, gable front structure is 3 x 3 bays. Its one-bay entry porch is supported by rectangular posts with chamfered corners and has a deck above.

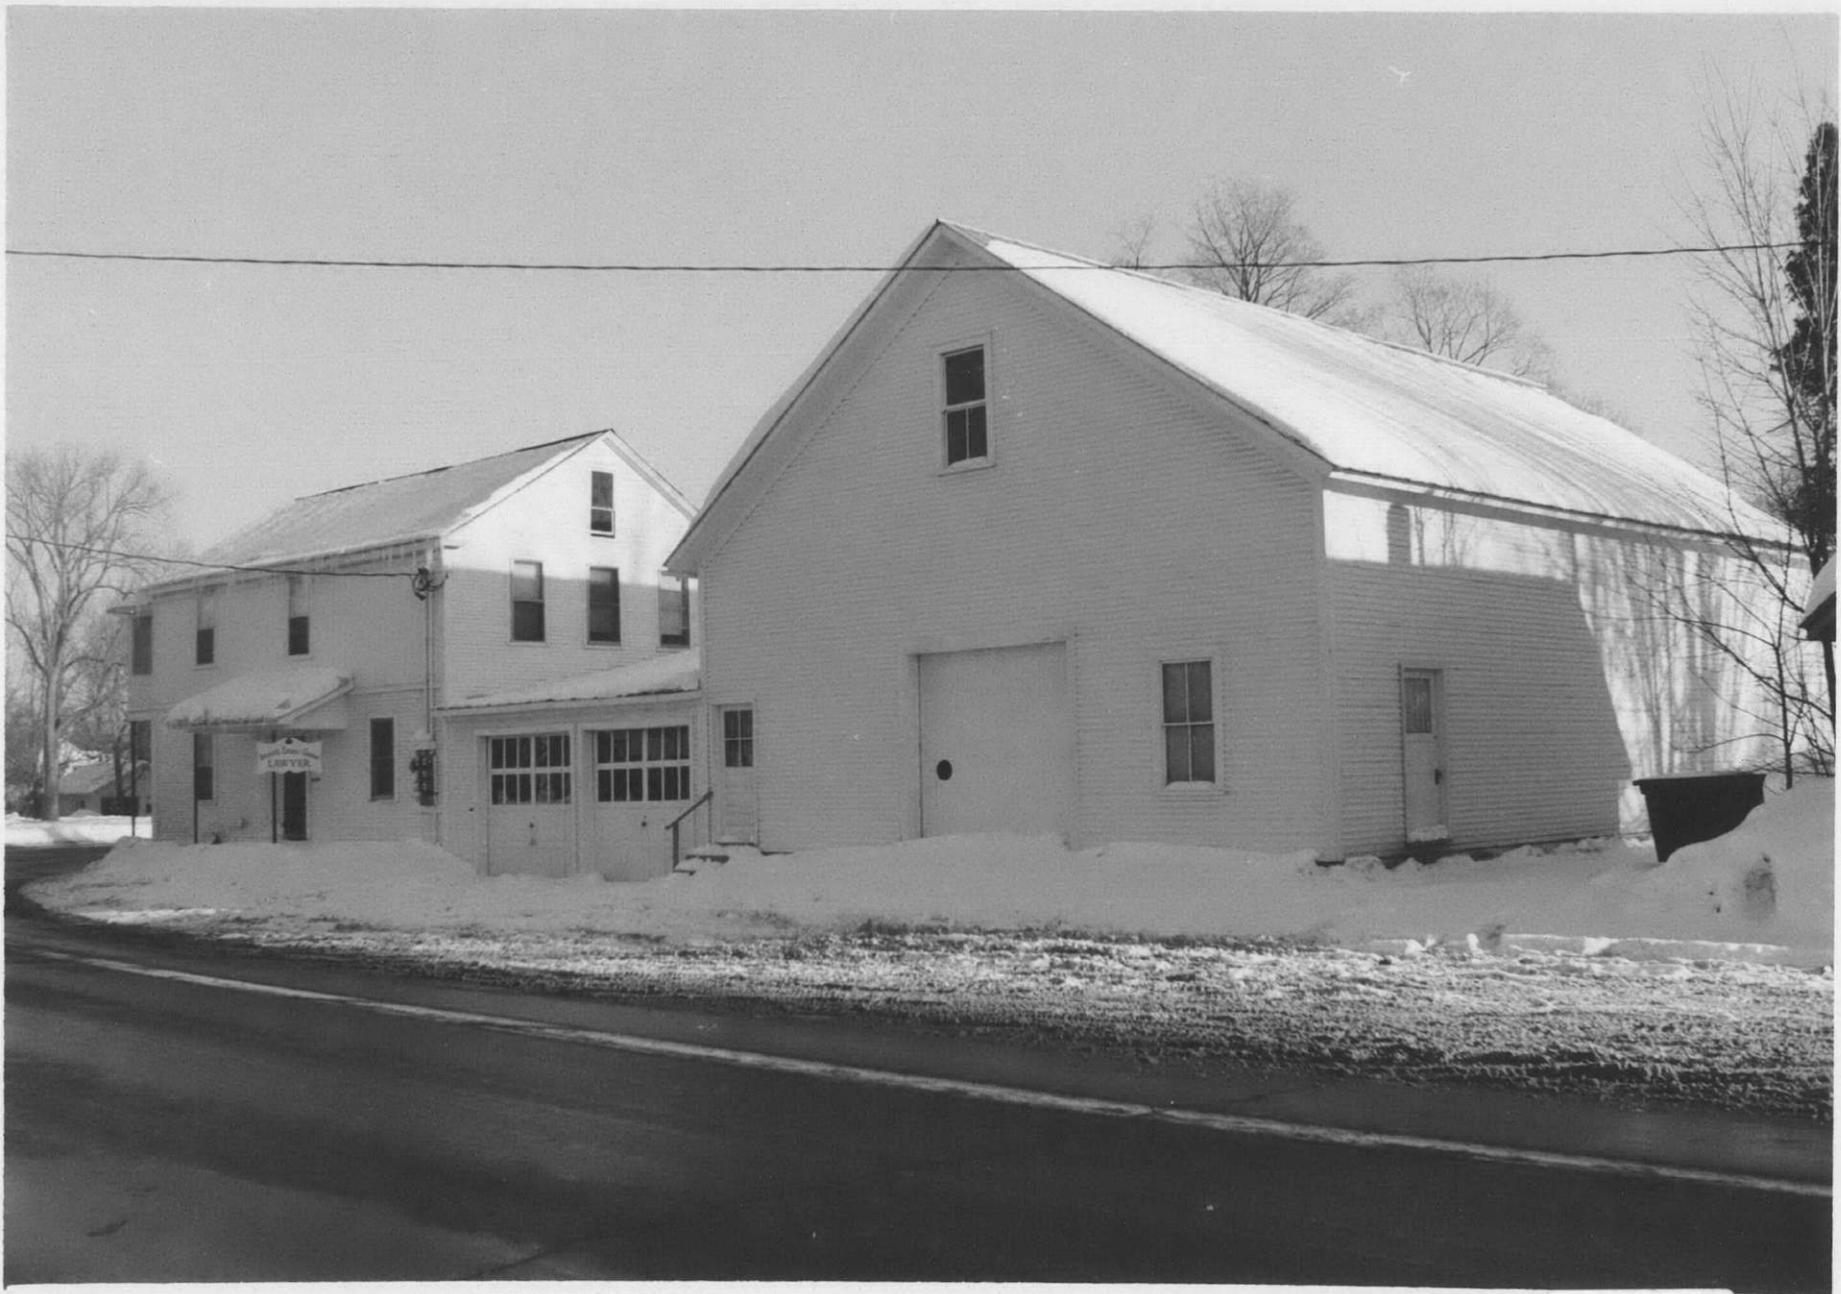
#20

DESCRIPTION:
 This structure was constructed c. 1819 and its first tenant was Thaddeus Fletcher who was just commencing the mercantile business with \$ 400 of borrowed money. He later moved to larger quarters and to Burlington, but remained an active supporter of Essex churches and town concerns. The structure has been added to many times over the years and is sided primarily in shiplap and clapboards.

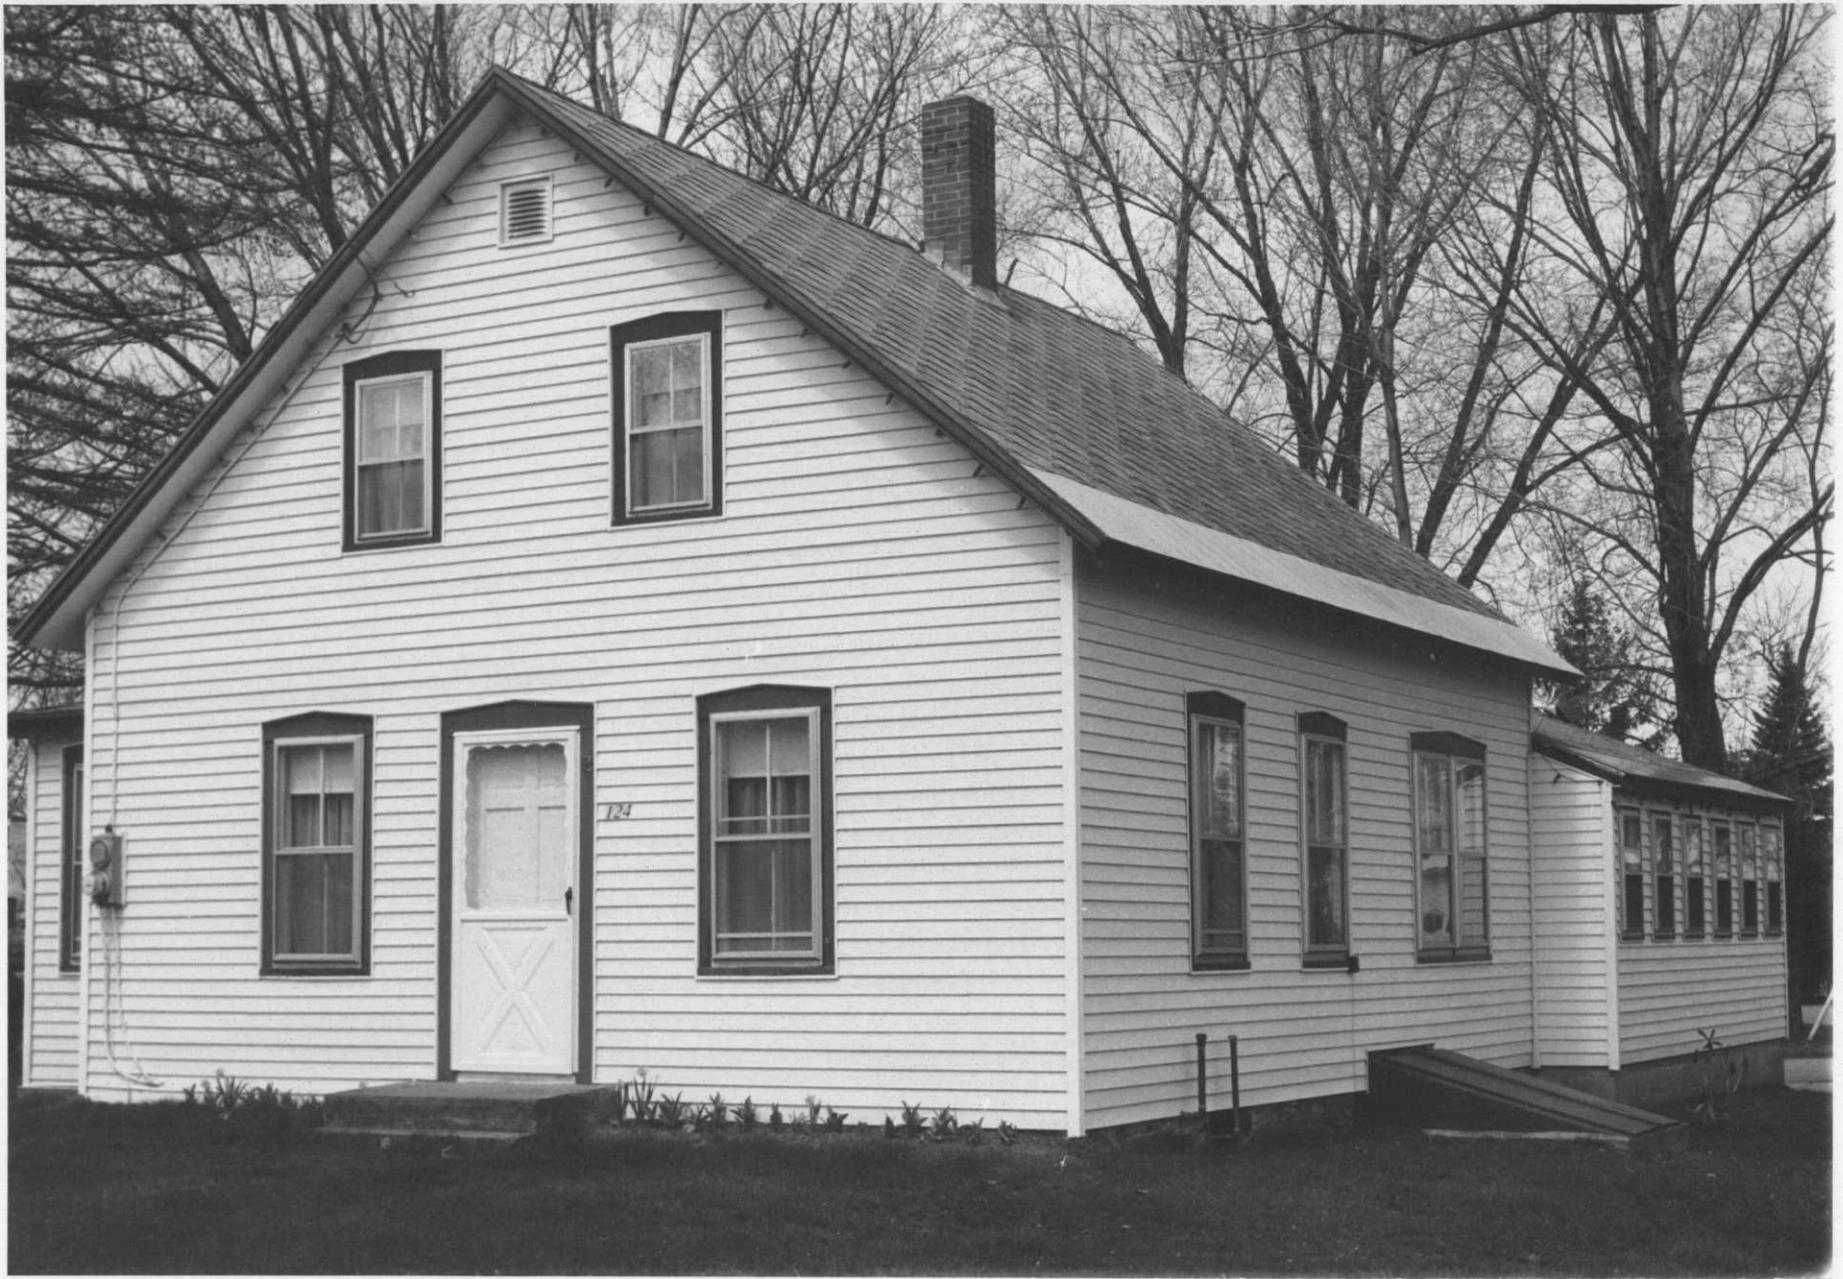
#19

The main block is gable-front, 1½ stories, 3 x 3 bays. Window surrounds are peaked. It was the residence of B. B. Butler, operator of a tavern on the northeast corner at Essex Center.

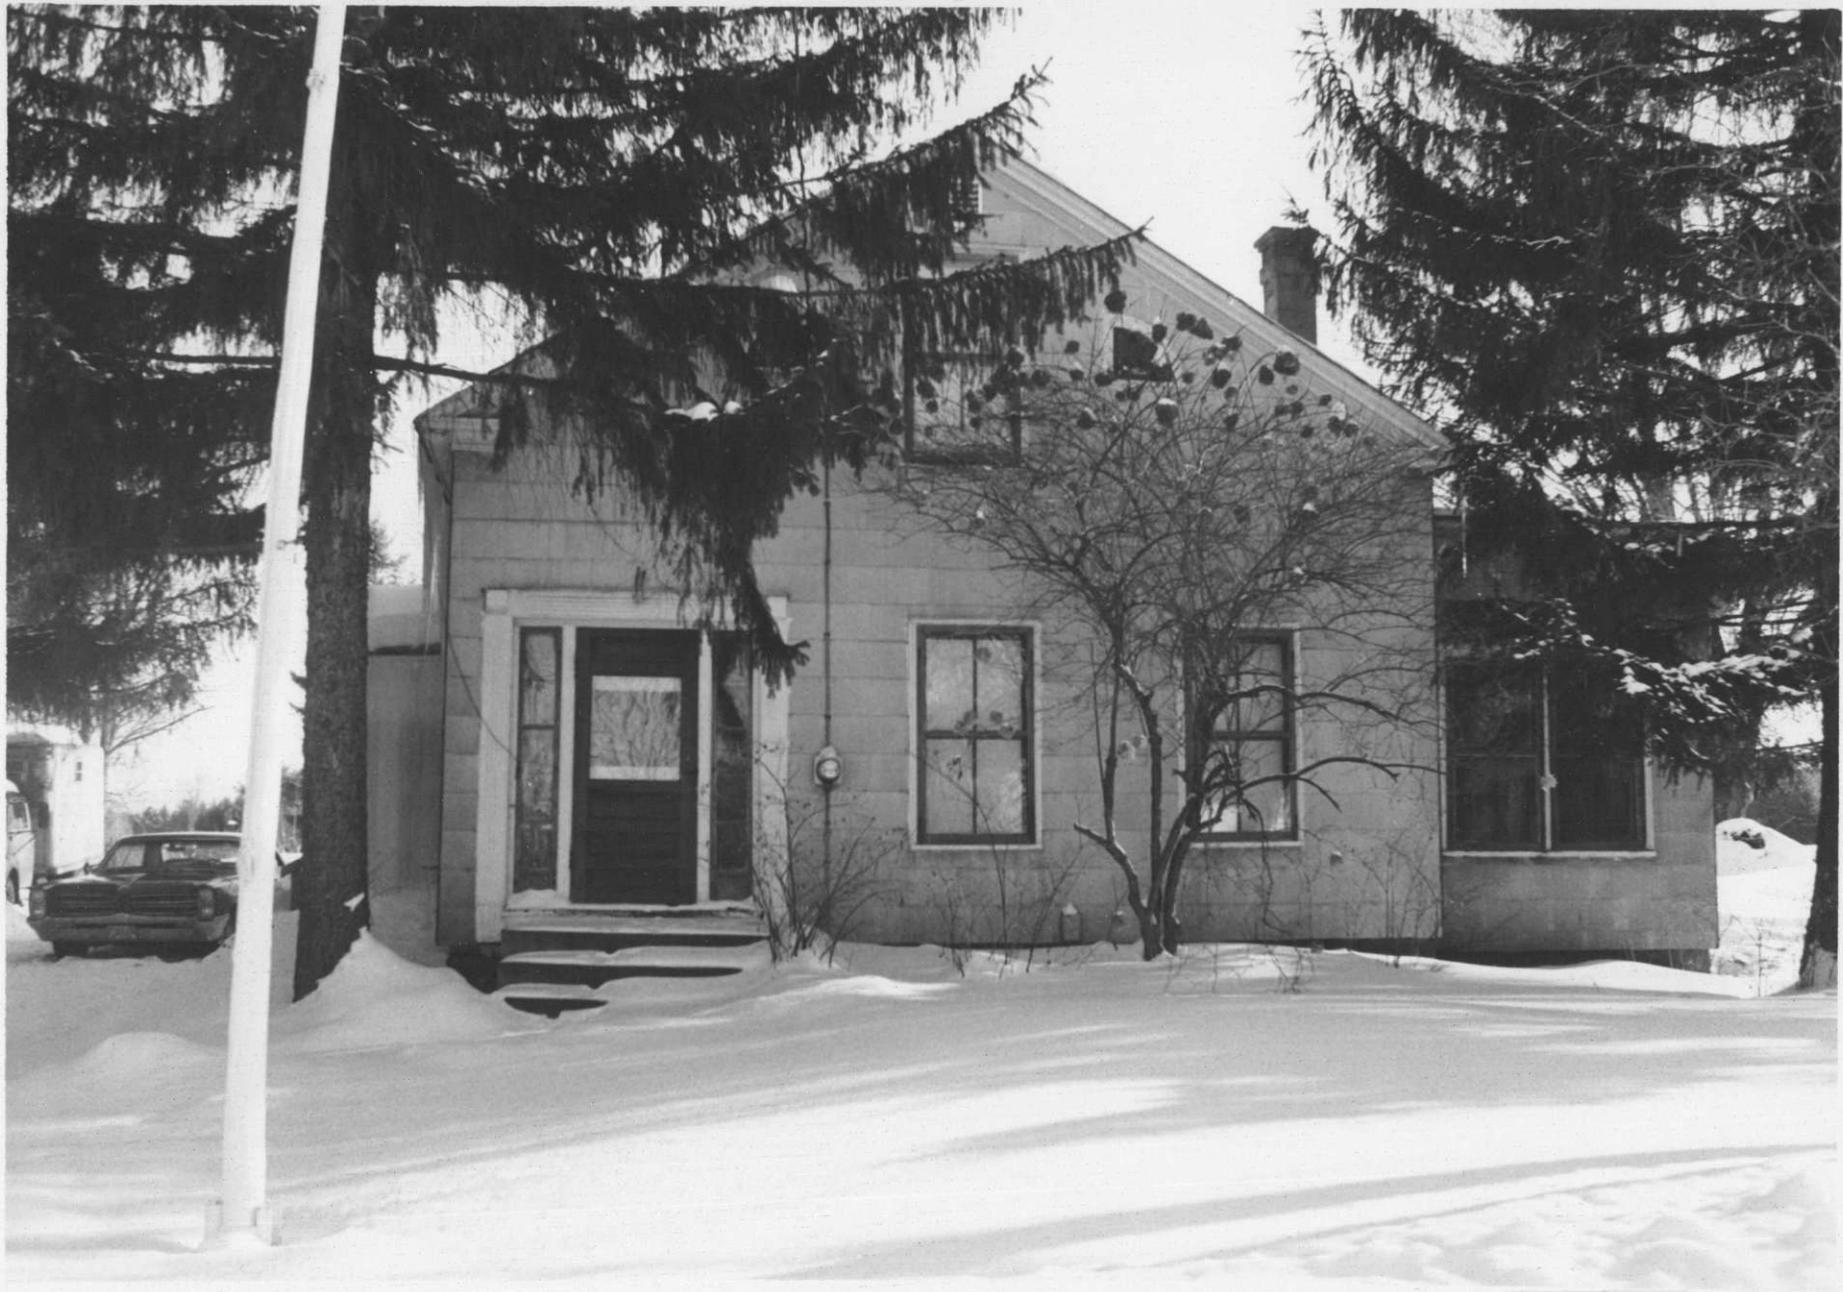
#22

DESCRIPTION:
 This structure is gable-front, 3 x 3 bays with sidehall plan. The door is flanked by side lights and molded panels. Quadrant lights flank the gable window. The house is sheathed in composite board.

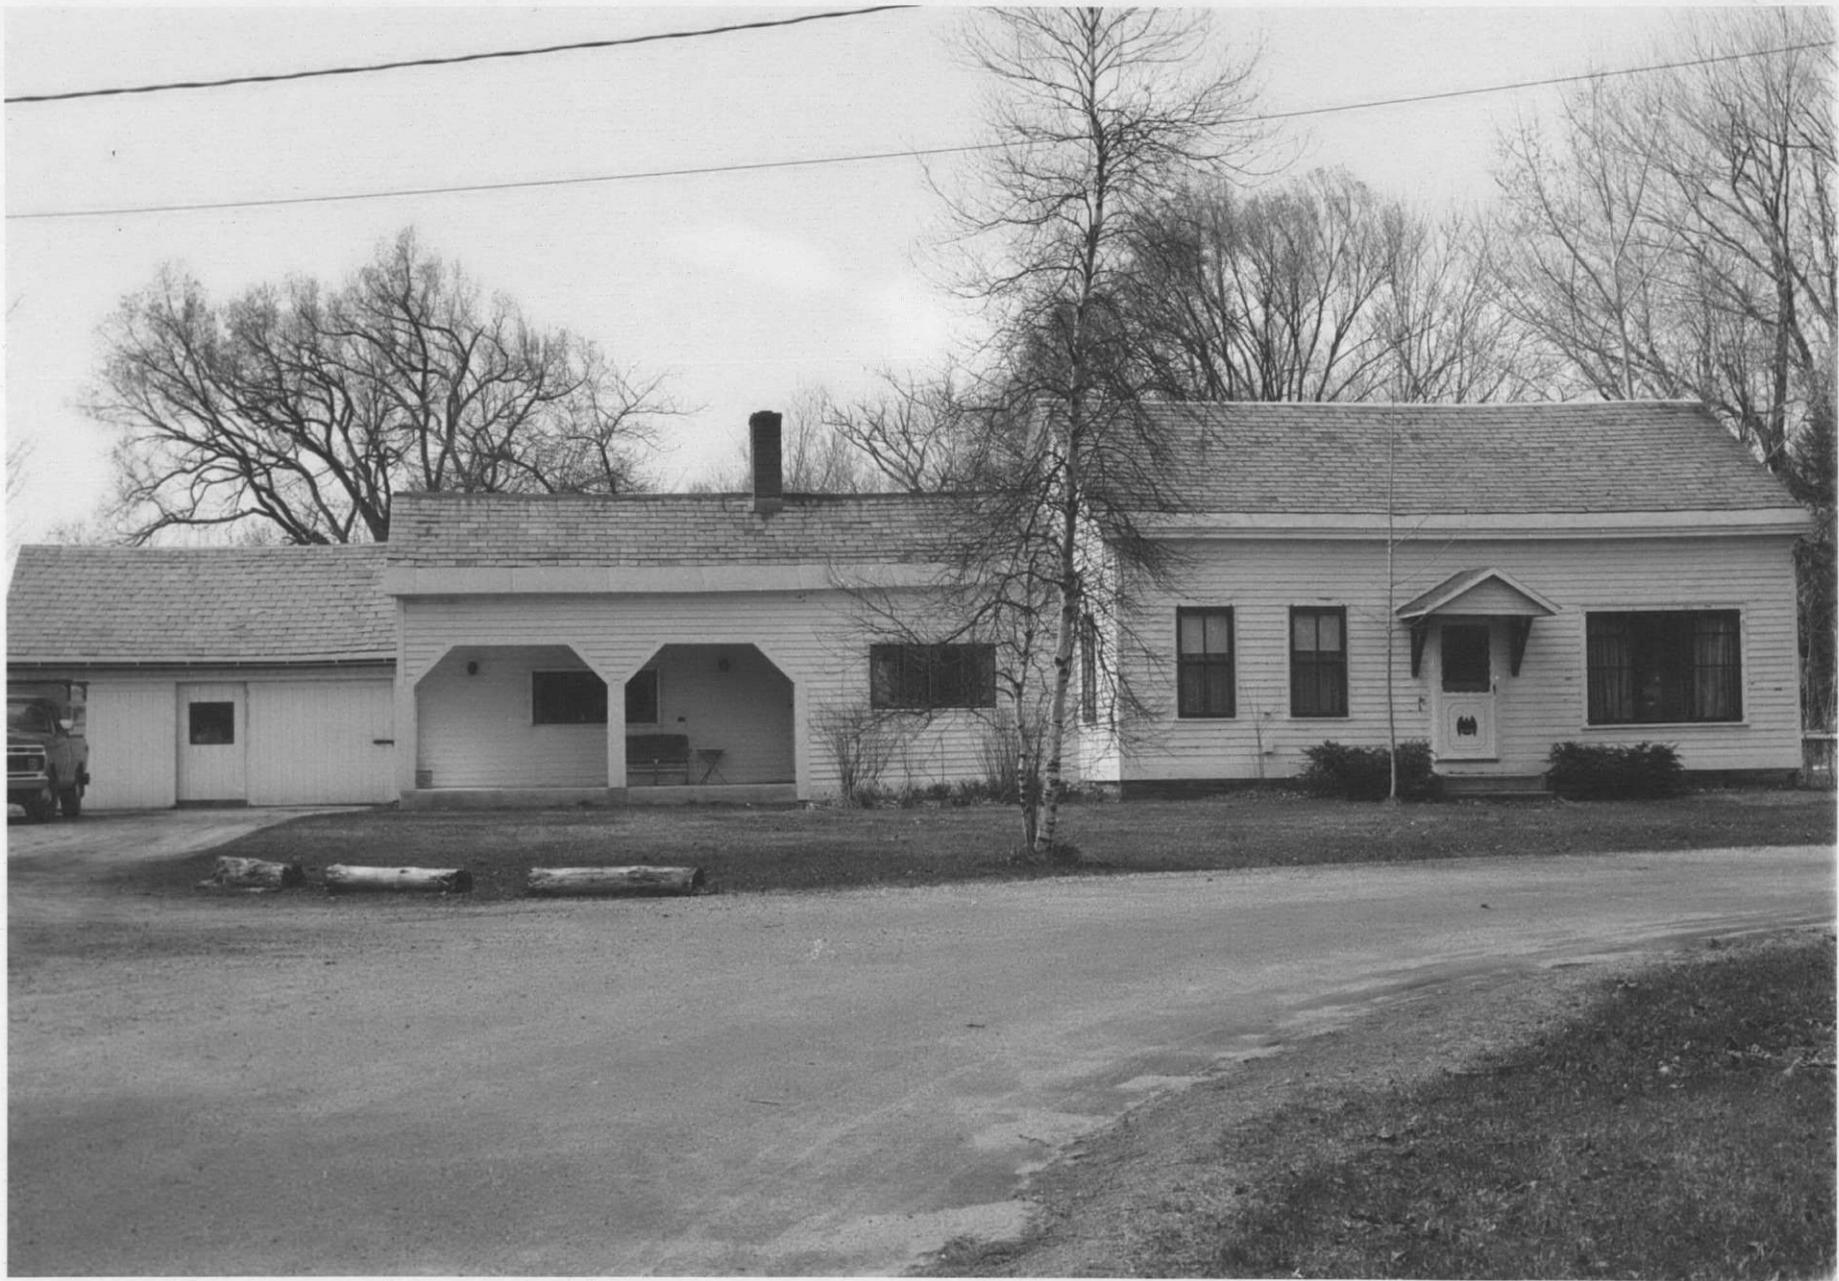
#21

DESCRIPTION:
 This structure is five bays wide with center hall plan. It is 1½ stories in height, and the door is sheltered by a peaked hood. A picture window replaces two of the original windows. The side (south) ell includes a shed area.

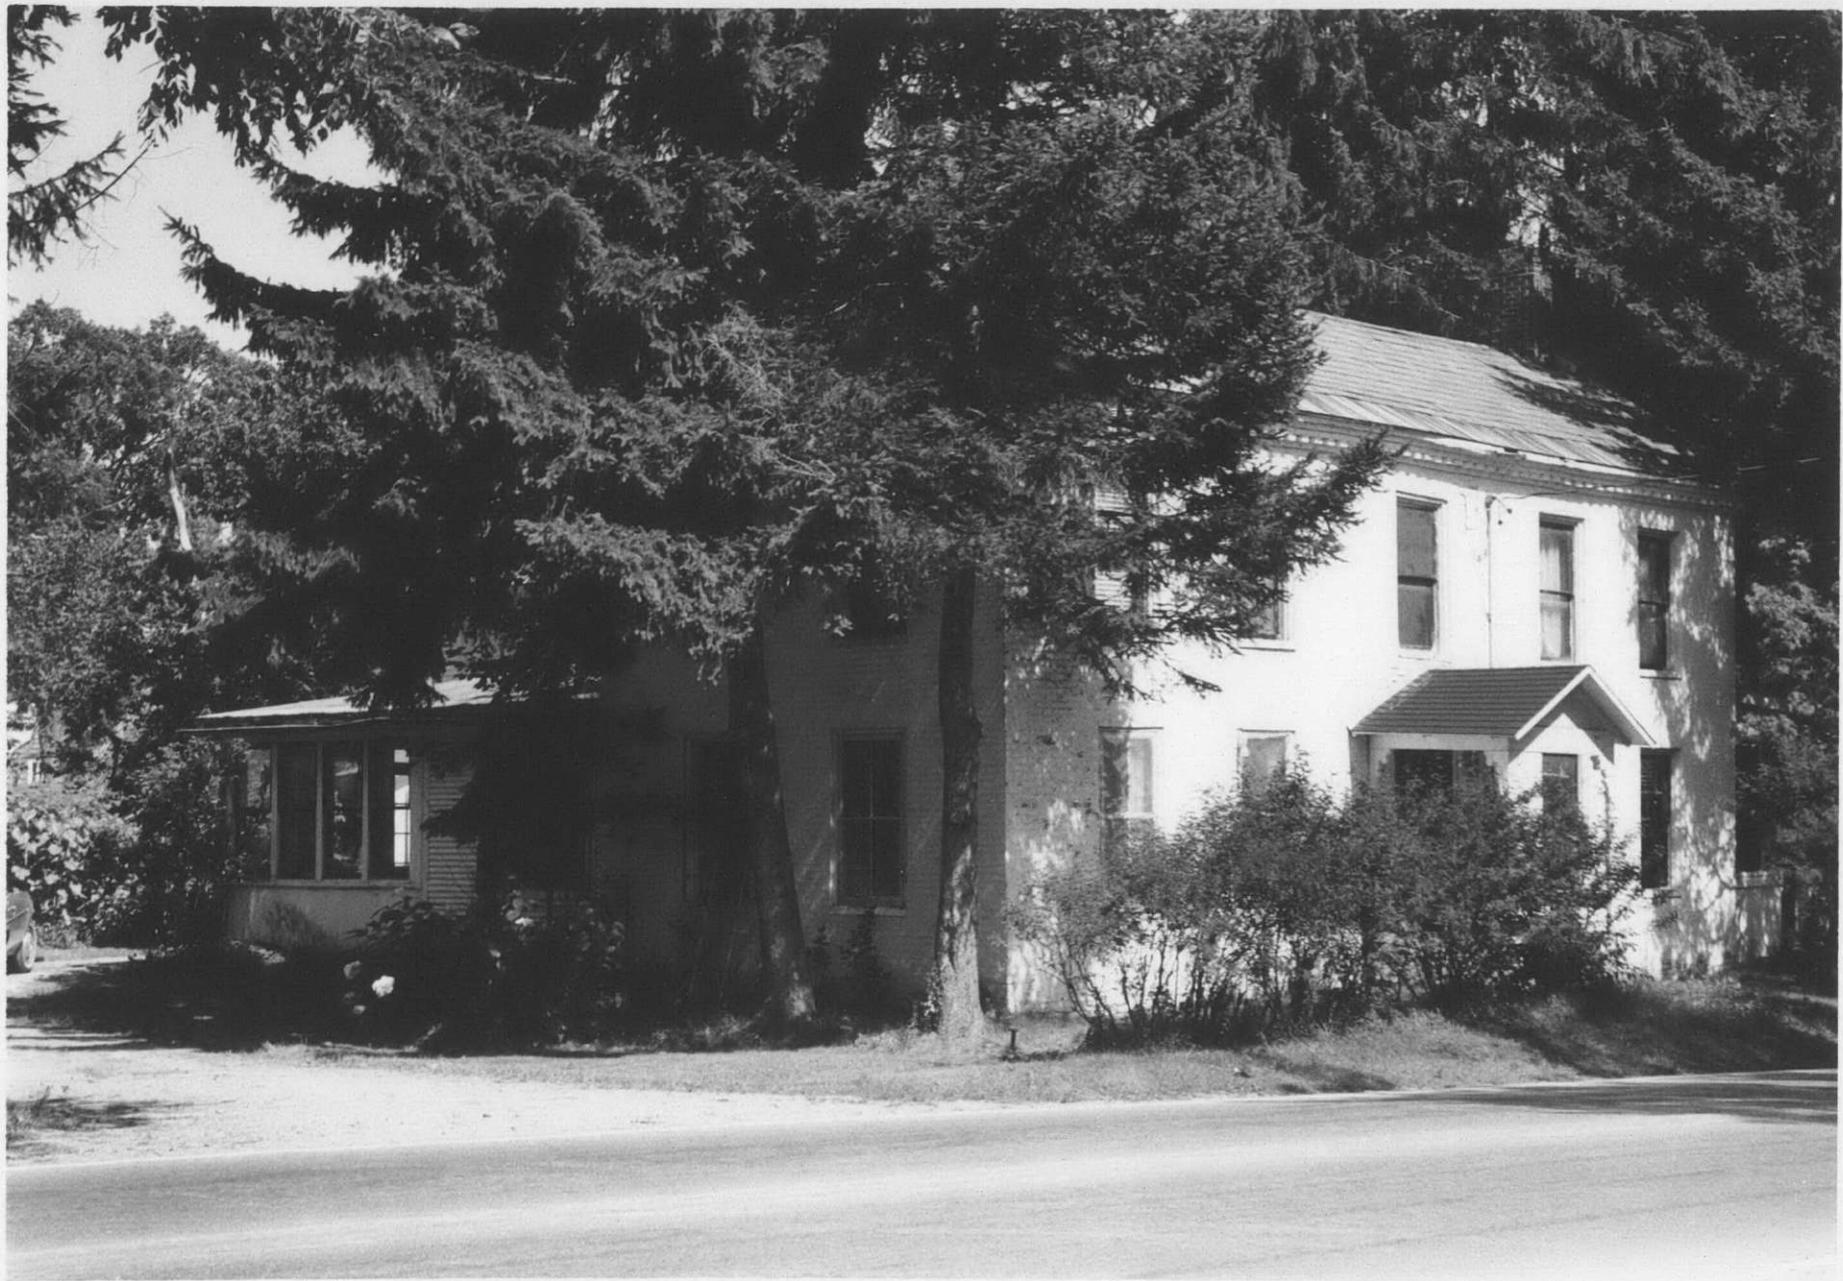
#24

This two-story brick structure is 5 x 2 bays on a center hall plan. Splayed flat-arched lintels adorn windows. The brickwork beneath the eaves mimics a denticular cornice. Slate sheathes the gable roof.

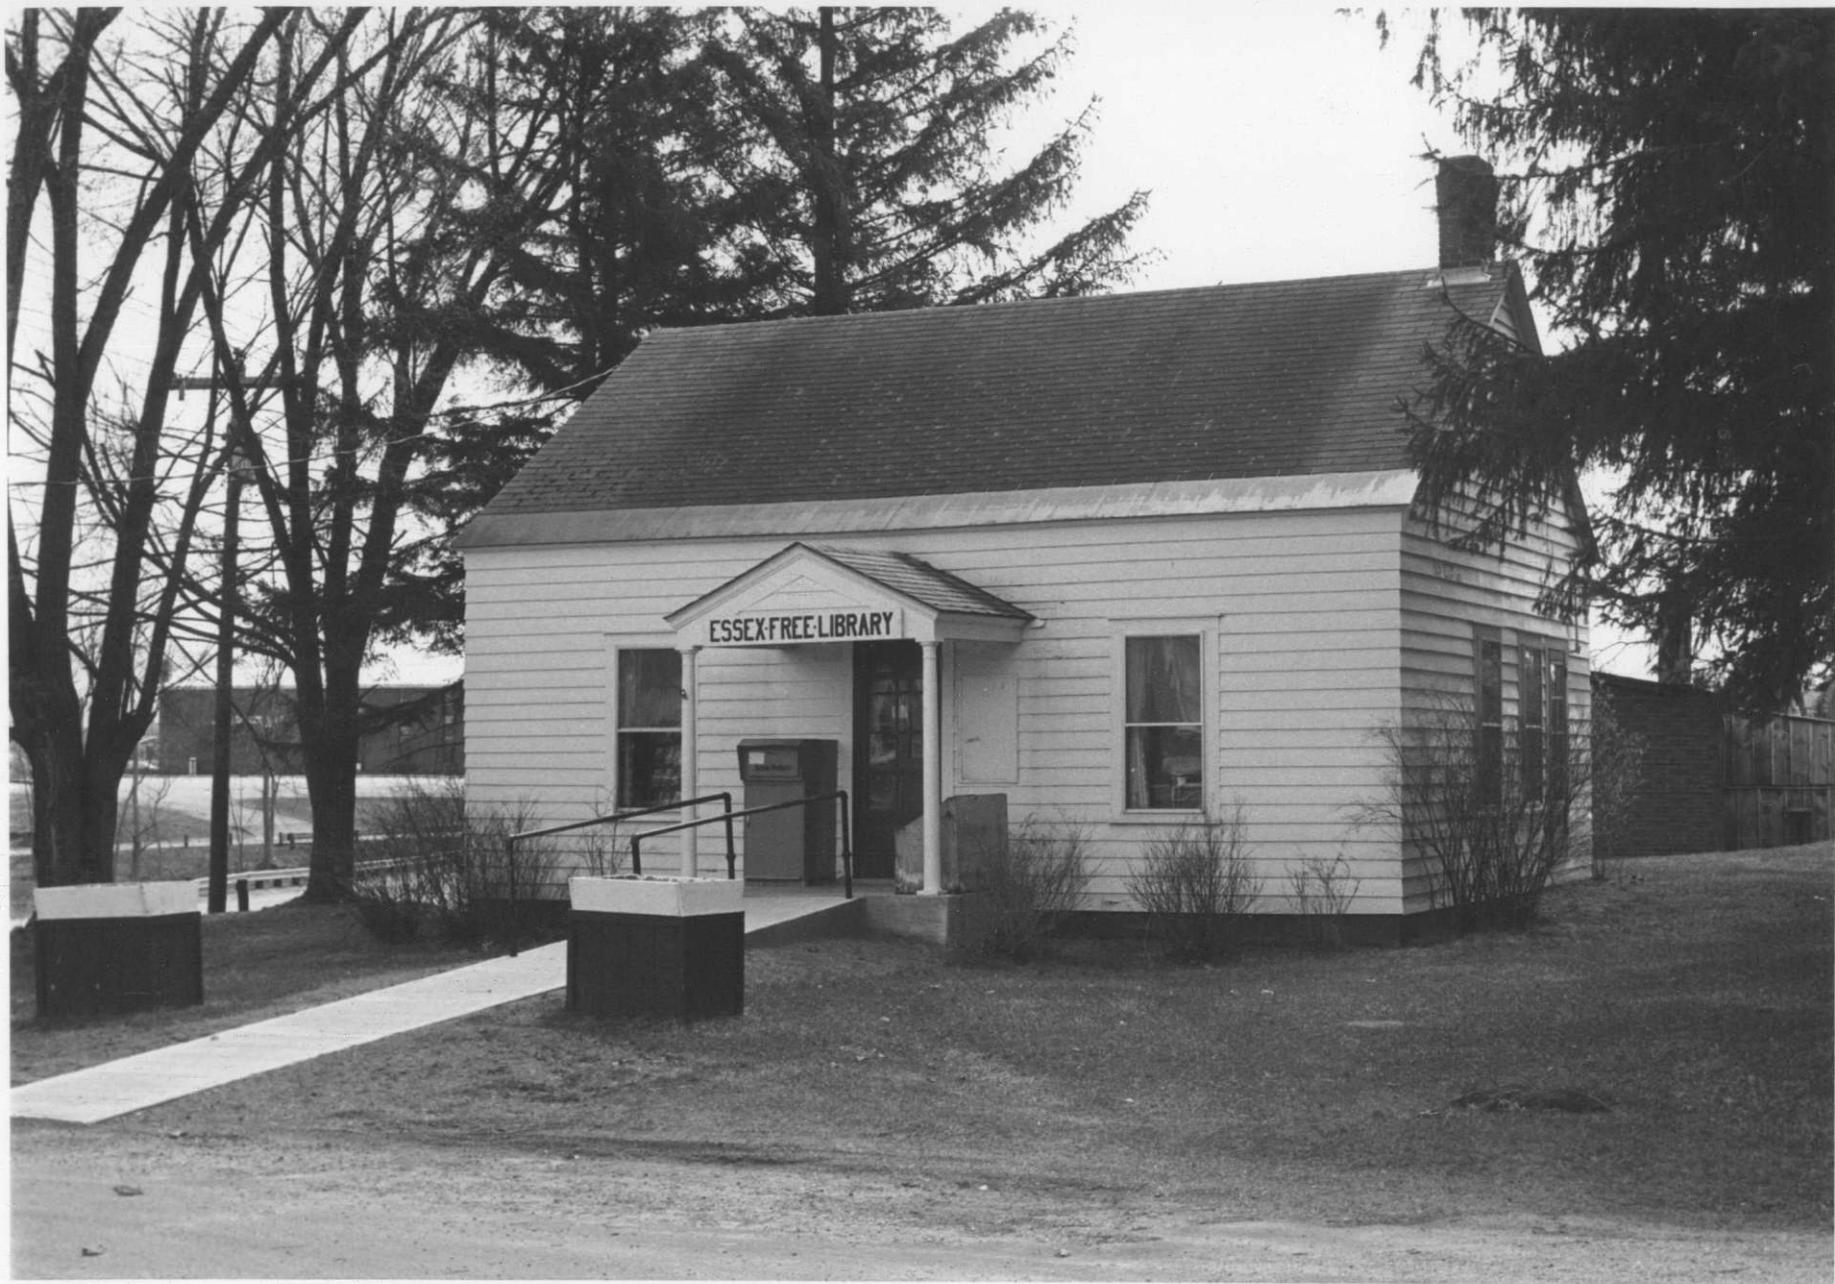
#23

DESCRIPTION:
 This one-story clapboard structure is three bays wide and three deep. Round columns support its peaked entry porch.

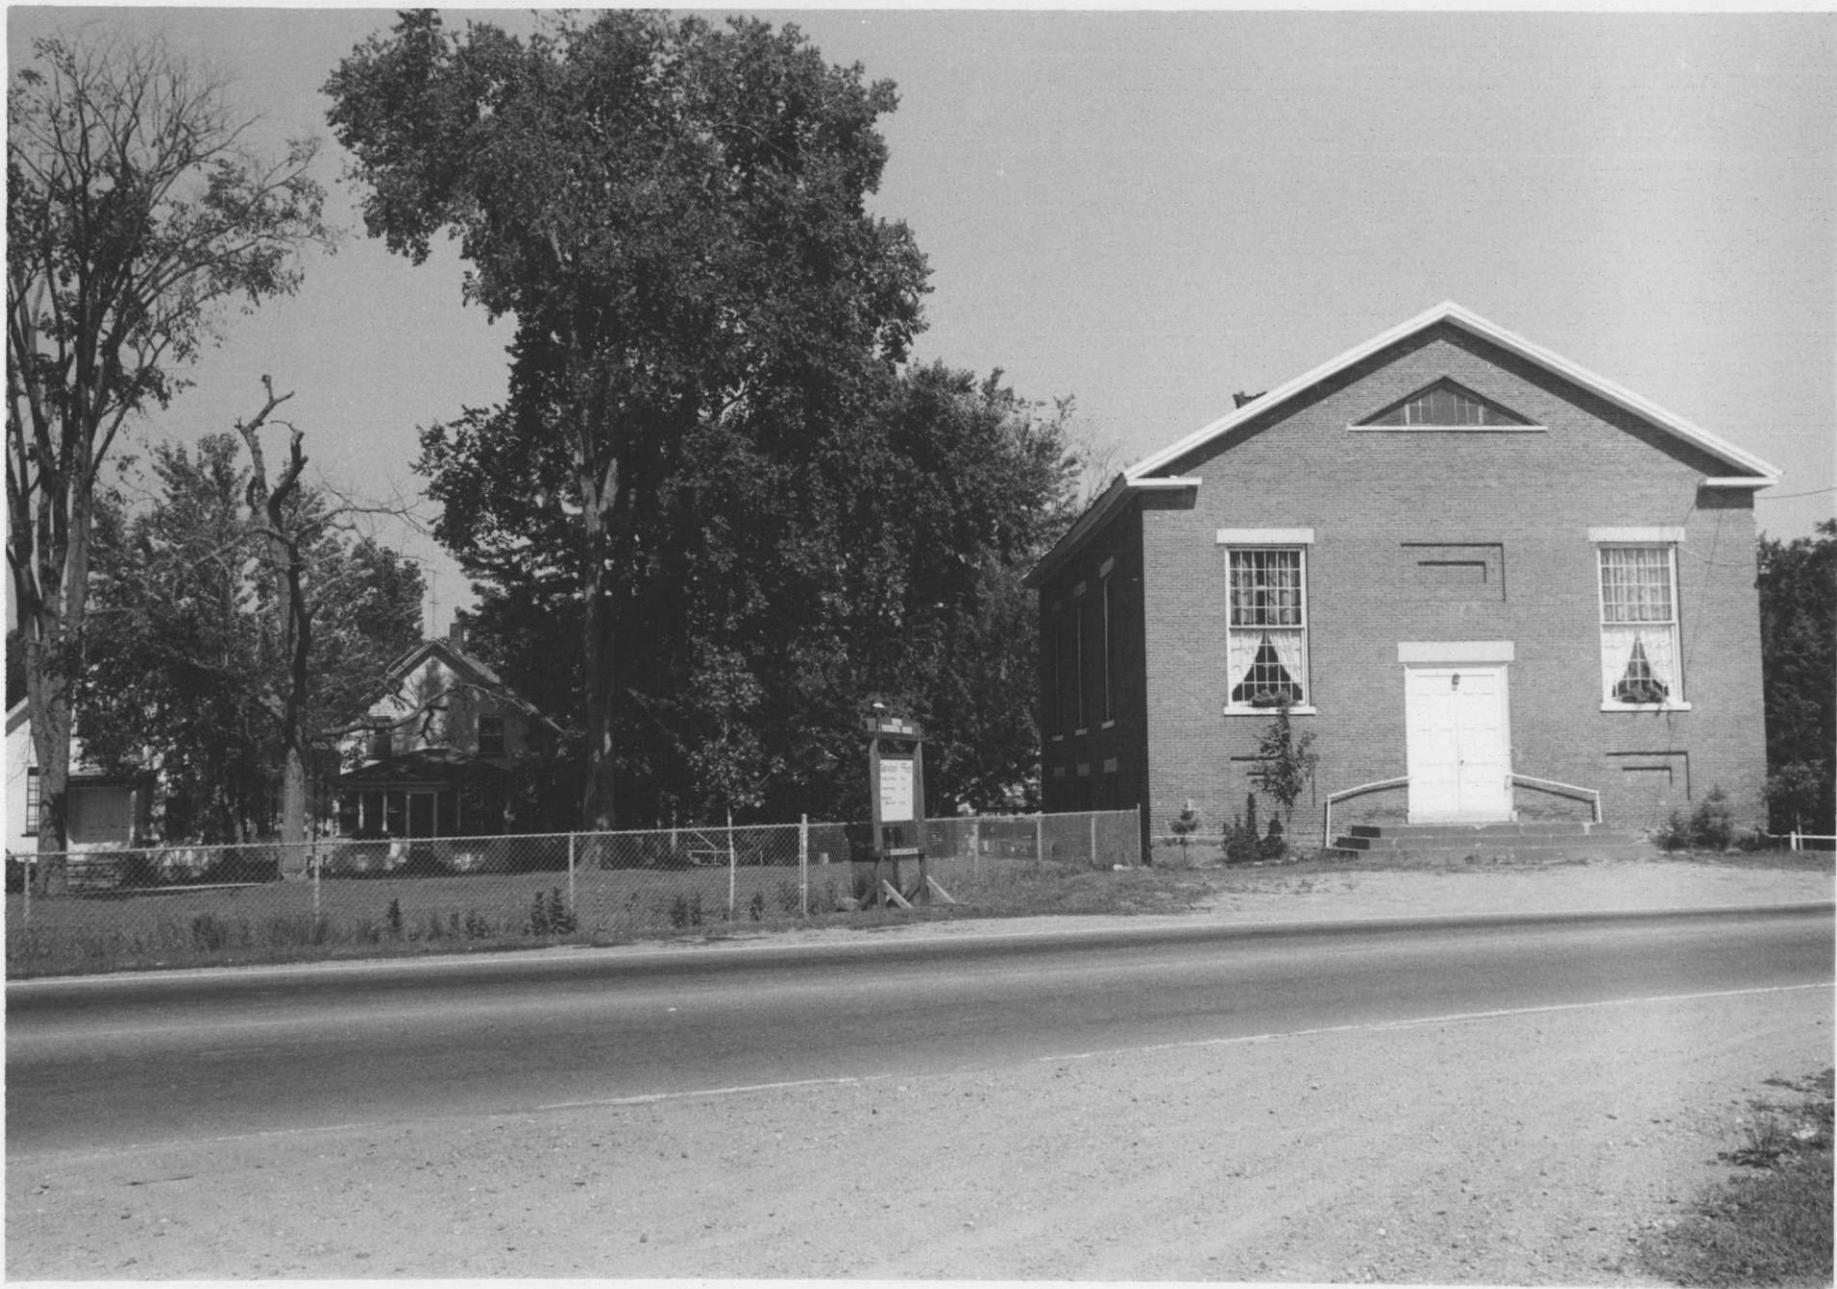
L to R
#27, 26, 25

This gable-front brick structure is laid in common bond. Double leaf panelled doors are crowned by a rectangular stone lintel, above is a recessed brick panel. On either side of the door are 24 x 24 sash windows crowned by a rectangular stone lintel, below which are recessed brick panels. The triangular attic light is partly glazed and partly louvered.

The house is gable-front, sheathed in clapboard. Window heads are molded and an enclosed 1-story porch is located on the front face. An ell extends to the side.

This clapboard-sided, gable-front schoolhouse is 3 x 7 bays. The elongated windows are crowned by peaked heads. The rear portion was added c. 1910. Vacant for many years, it will again be used for classroom space this fall.

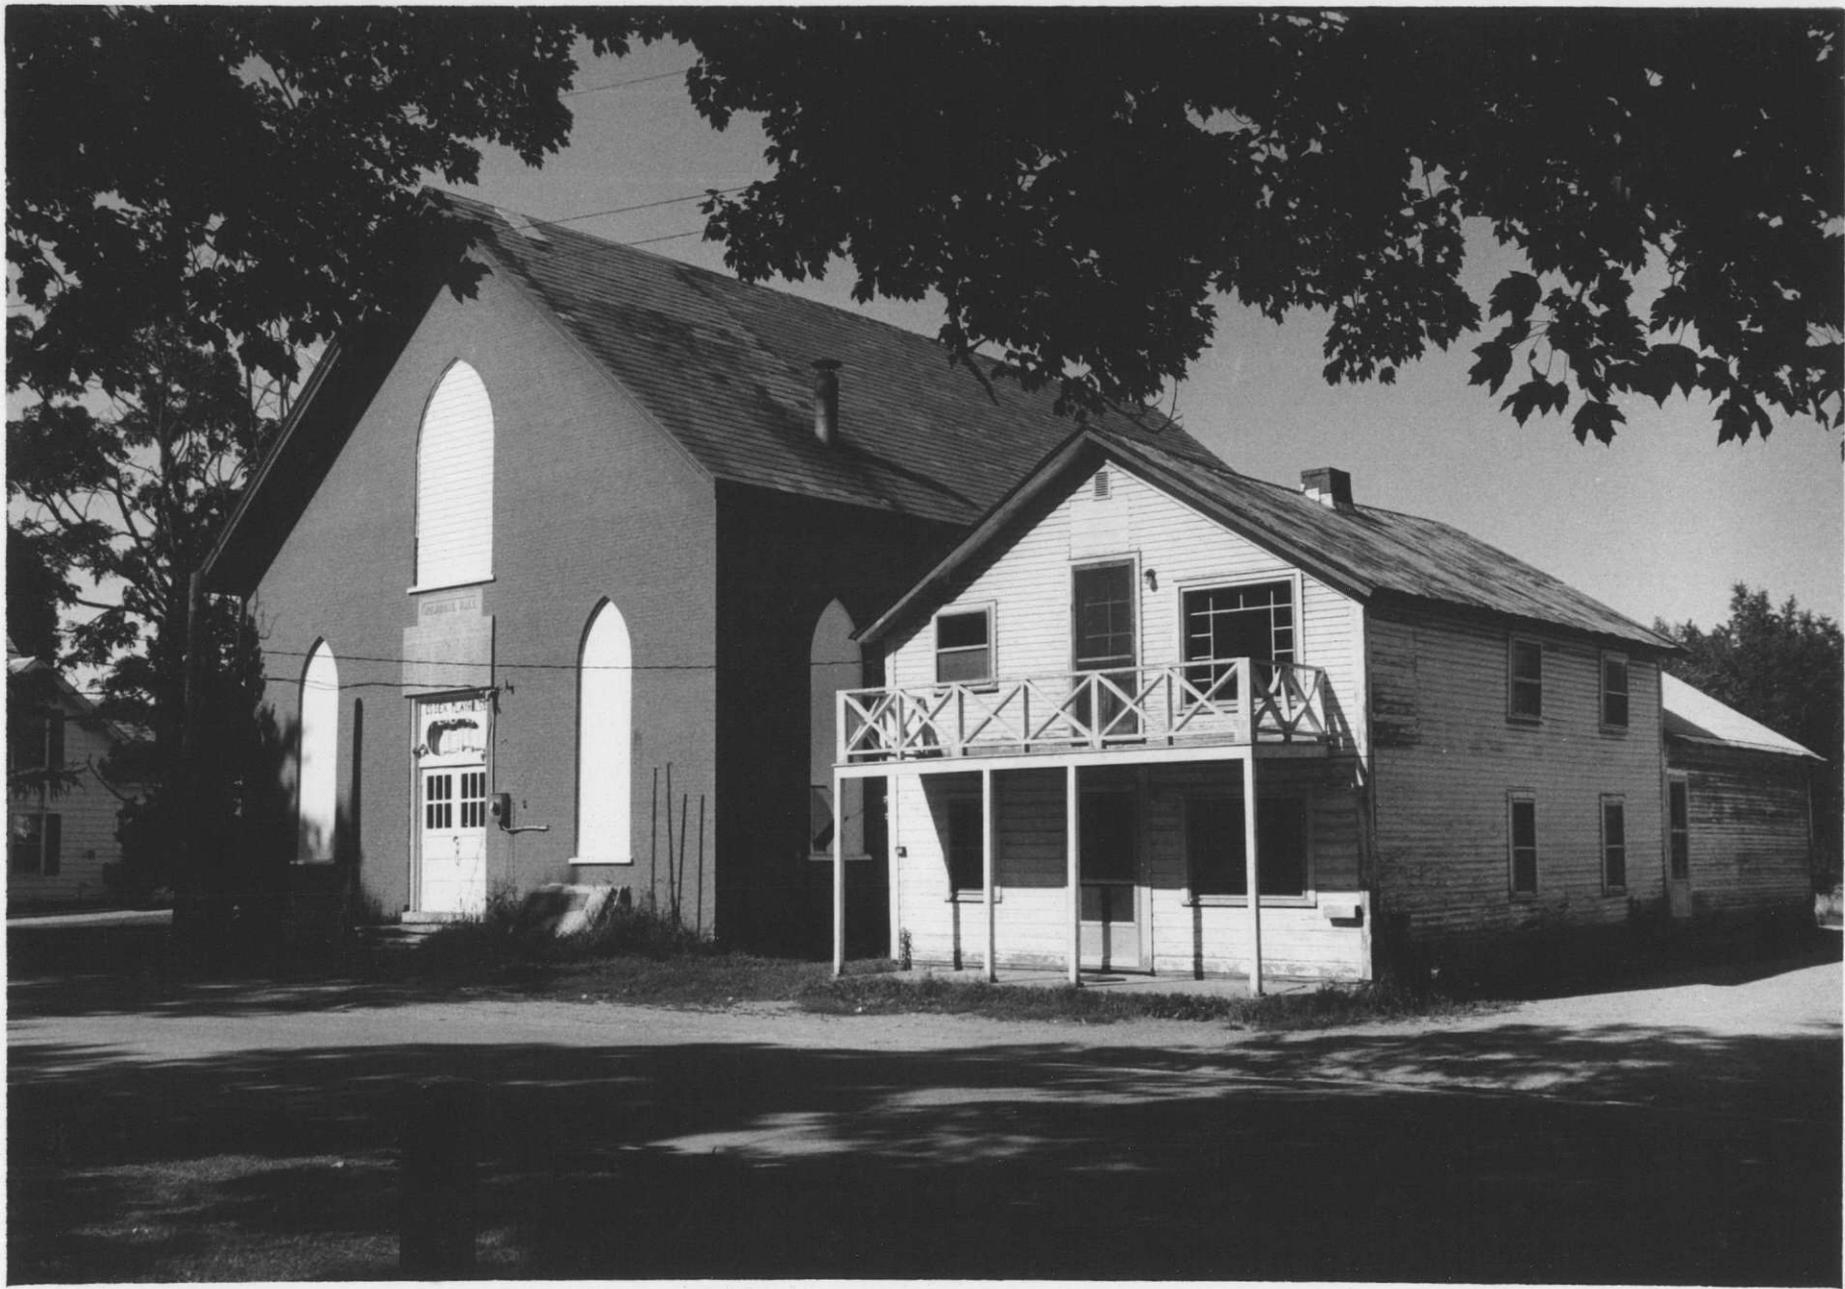
#30,31

This 2-story gable-front structure is 3 x 2 bays, sided in shiplap. The one-story front porch has a deck above.

The brick walls are laid up in common bond. The structure is gable-front, 3 x 3 bays. The paired front doors are flanked by pointed arch windows now boarded up. Above the door is another boarded pointed-arch window. Originally built to serve as a town hall, Memorial Hall is now used as a playhouse.
