HISTORIC SITES & STRUCTURES SURVEY
District Complex Survey Form

SURVEY NUMBER: 0405-23

Essex Center Historic District

HISTORIC SITES & STRUCTURES SURVEY
Individual Structure Survey Form

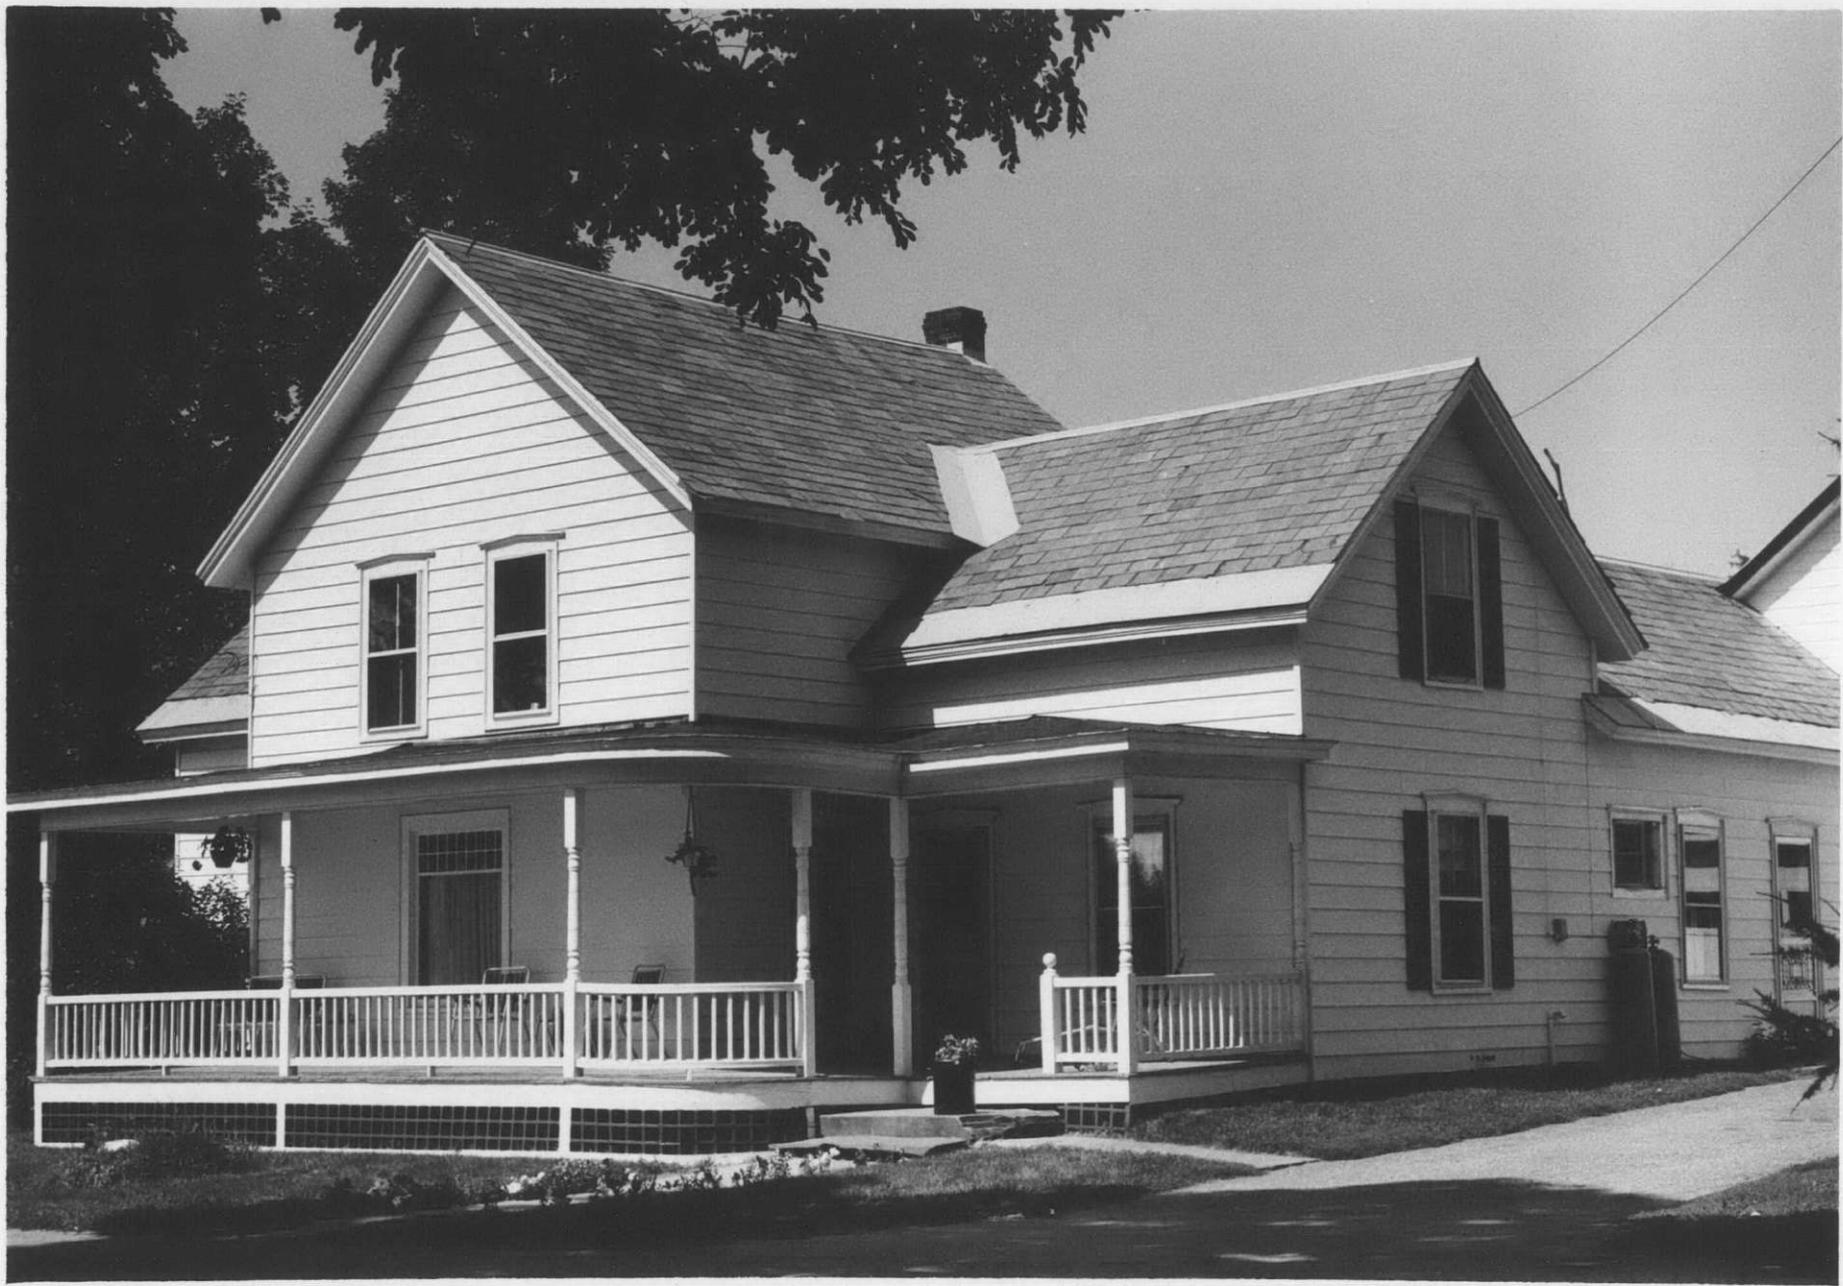
#32

This vinyl-sided structure consists of a gable-front main block flanked by wings. Peaked heads top windows. The veranda is curved.

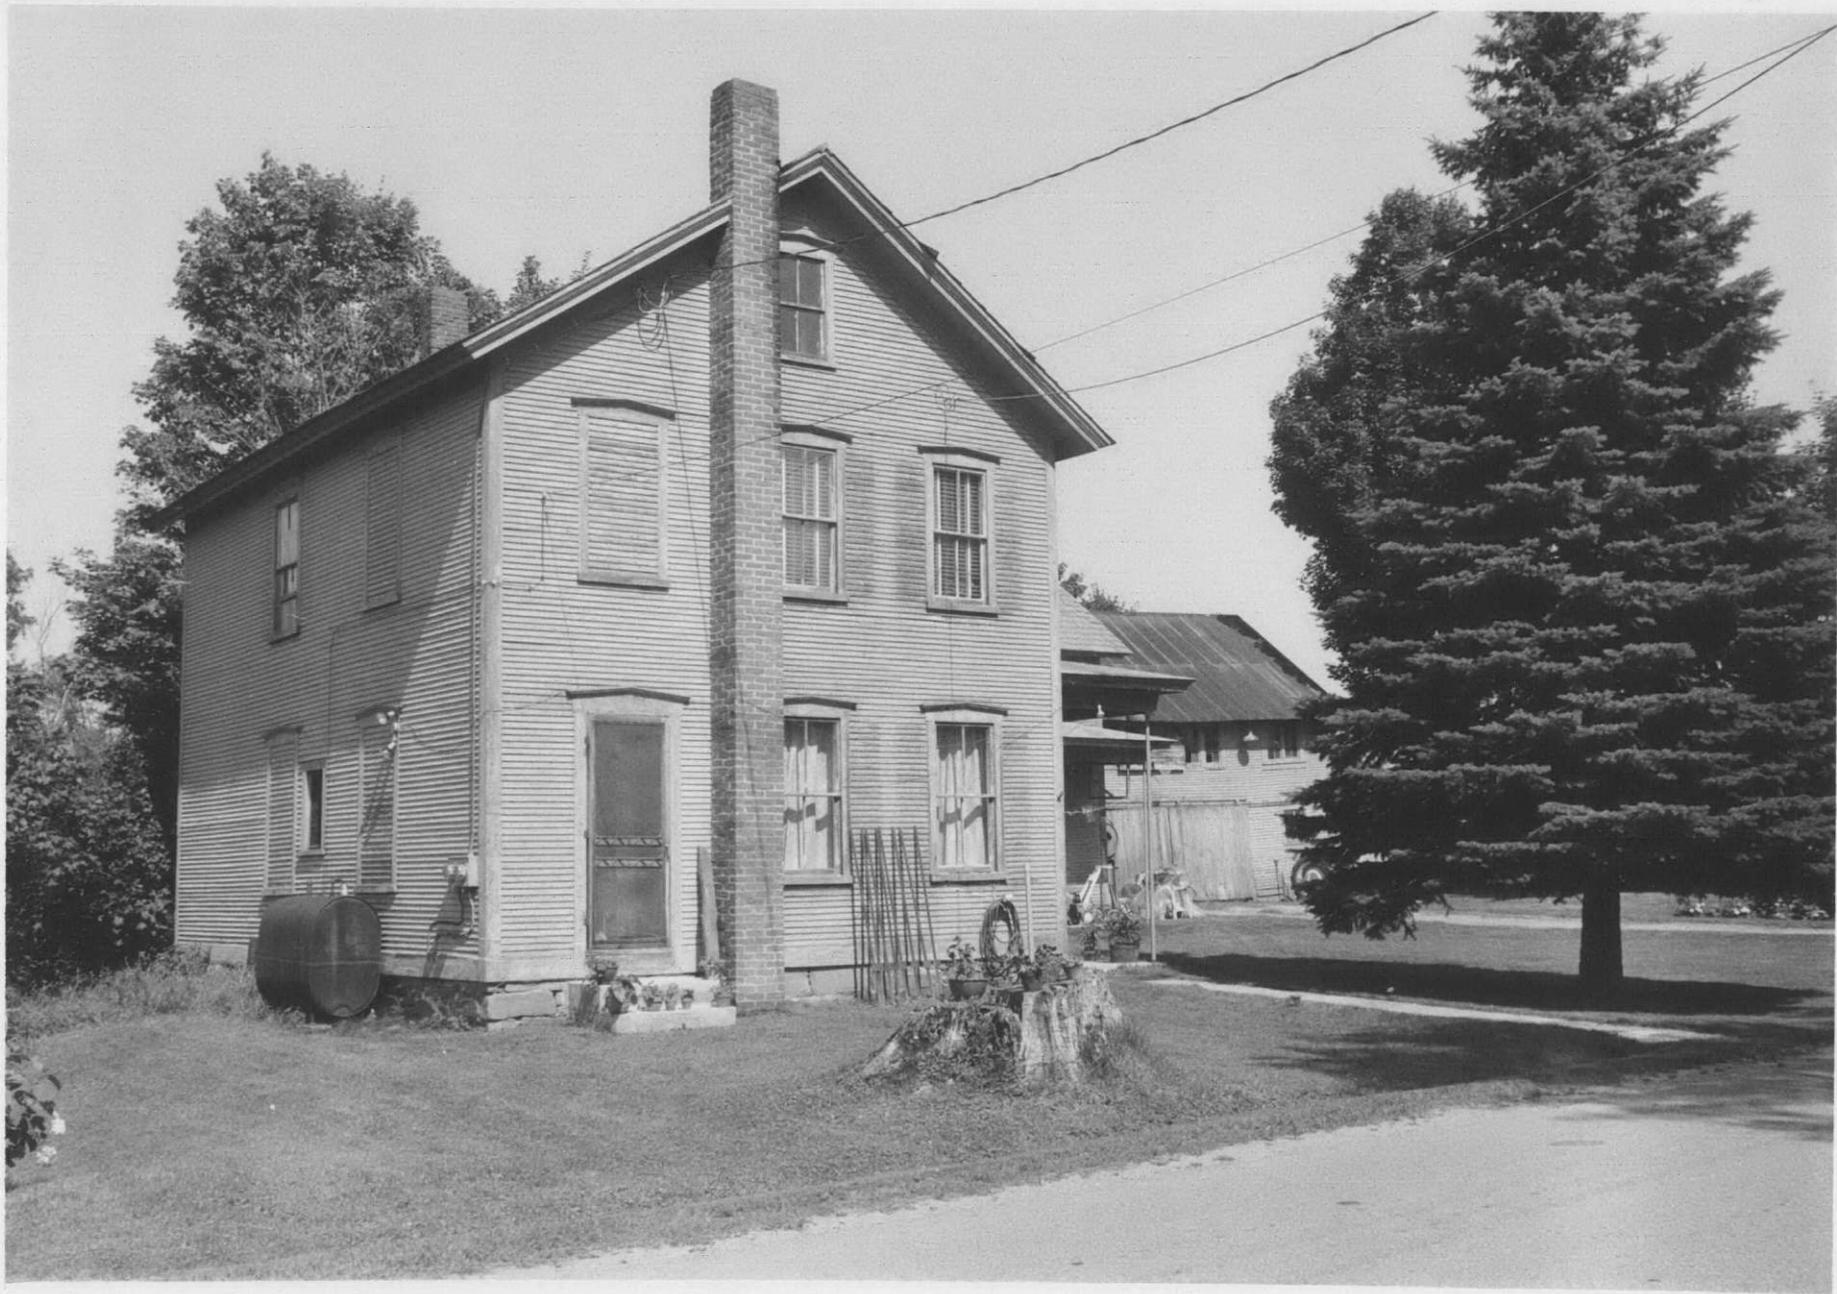
#33

The main block is gable-front, 3 x 2 bays, sidehall plan. An ell extends to the south. The molded window heads are also peaked.
